# APPENDIX E

MANSFIELD ATSP FIELD OBSERVATIONS  
AND RECOMMENDATIONS

**To:** City of Mansfield  
**From:** Monica Powell, AICP, RSP<sub>1</sub>  
**Date:** November 5, 2025  
**Subject:** Mansfield ATSP – Field Observations and Recommendations

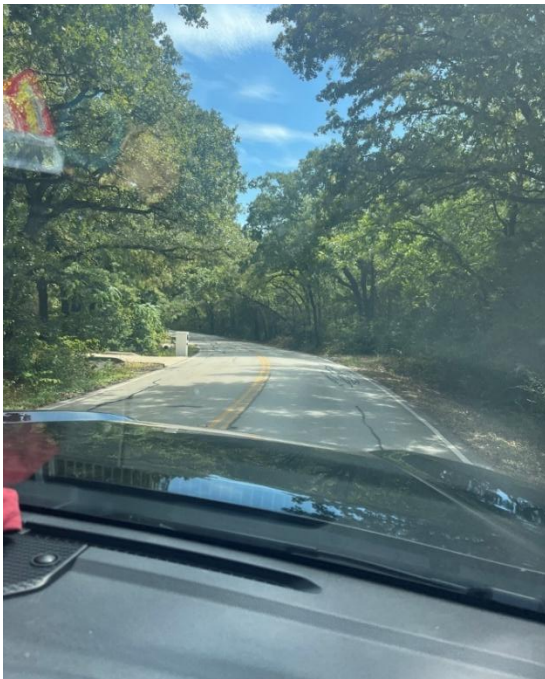
Figure 4. Flashing Chevron Signage Recommended

Very poor sight distance was observed around curves. Due to the lack of visibility in the road curvature, it is recommended that flashing chevron signage be added to give drivers an indicator of the curve. Placing edge lines will also allow road users to more easily navigate the curve's shape. (Figure 4)

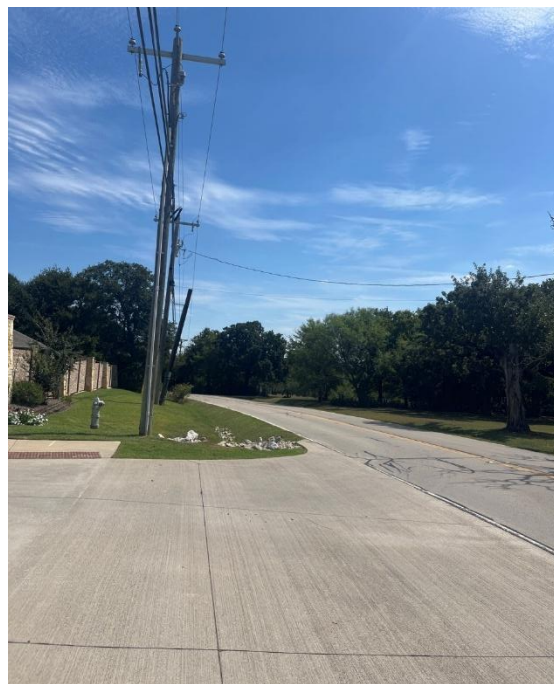
Figure 3. Sight Distance Issues Looking East

Very poor sight distance looking east was observed. Changing the horizontal curve radius will allow for better sight distance. (Figure 3)

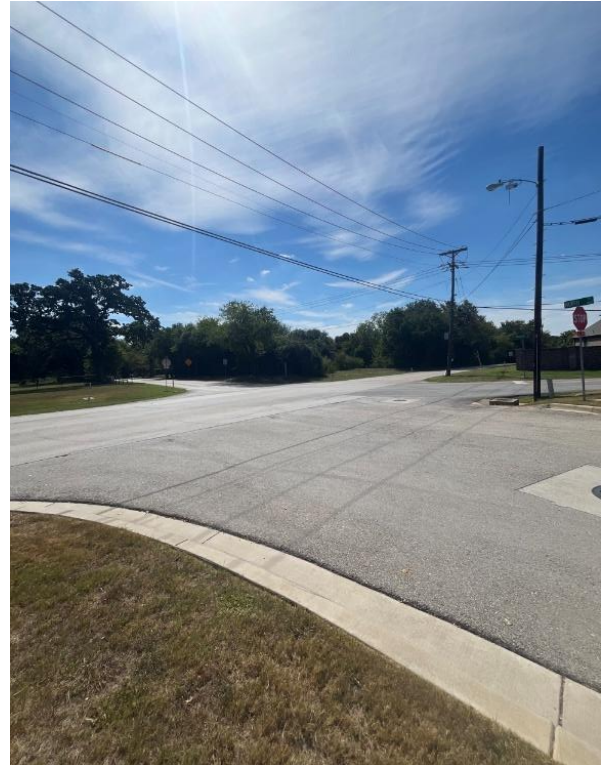
Figure 5: Proposed Roundabout

With an existing large 5-legged intersection, a roundabout is recommended to add a roundabout to control traffic flow and reduce speeds. (Figure 5)

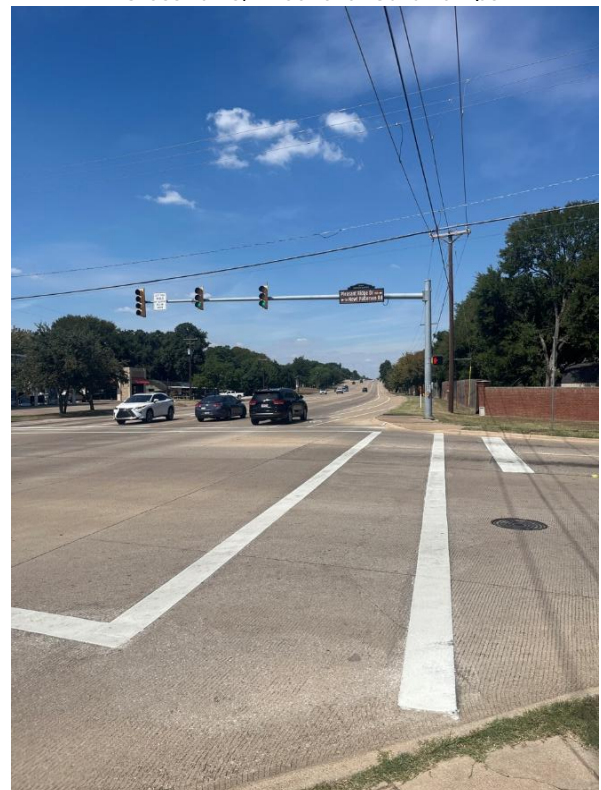
Figure 6. Full Signal Rebuild Needed, Upgrade Crosswalks, Directional Curb Ramps

It is recommended to do a full signal rebuild, including new signal heads, crosswalks, directional ramps, curbs, and backplate lighting. (Figure 6)

To ensure visibility of the crosswalk, it is recommended to upgrade the existing striping to be continental style. (Figure 6)

It is recommended to install directional curb ramps for ADA-compliant pedestrian crossings. These ramps will provide safe and convenient transitions between sidewalks and crosswalks for pedestrians, including those using wheelchairs, strollers, or other mobility aids. (Figure 6)

Proper lighting makes both pedestrians and vehicles more visible to each other, reducing the likelihood of accidents, particularly during nighttime or low-light conditions. To reduce the number of crashes, it is recommended to install additional lighting. (Figure 6)

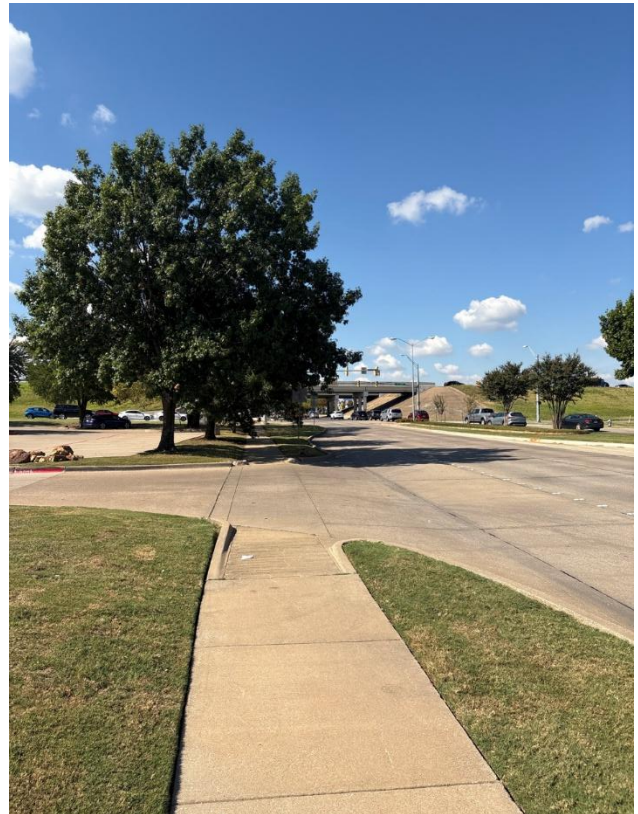
*Figure 7. Trim Vegetation*

To improve sight distance, it is recommended to trim the vegetation that hangs over the roadway. Overhanging vegetation obstructs drivers' views, particularly when looking north, increasing the risk of accidents. Trimming this vegetation will enhance visibility, allowing for safer and more informed driving decisions. (*Figure 7*)

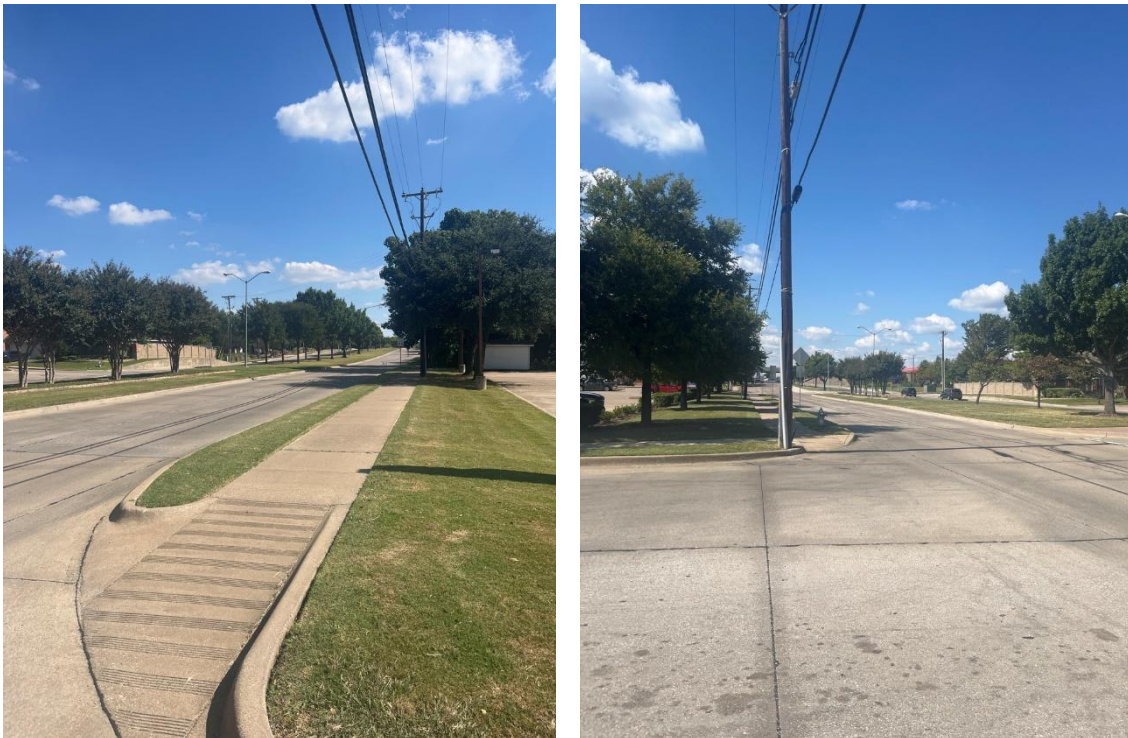
*Figure 8. Poor Sight Distance Looking West – left; Looking East – right | Hooded Left Turn Recommended*

Poor sight distance from both sides occurs at this intersection. Converting the open median into a direction median is recommended, creating a hooded left turn for the west- and eastbound left turns. (Figure 8)

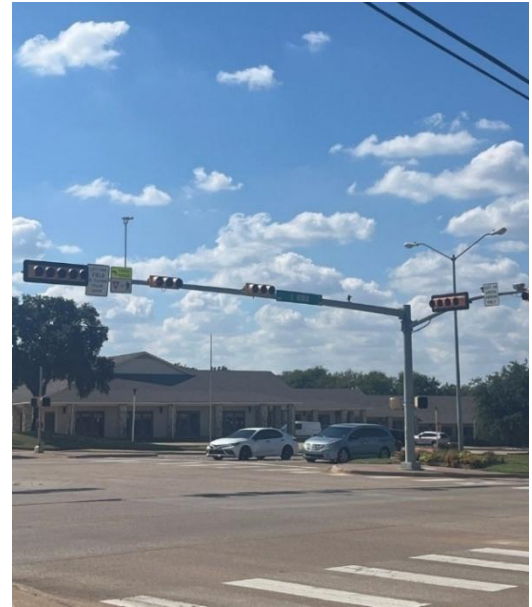
Figure 9. Add Retroreflective Backplates & Update Signage and Wet Pavement Markings

It is recommended to add retroreflective backplates to the existing signals. This enhances visibility for road users, reducing crash risk, and enhancing safety for all road users. (Figure 9)

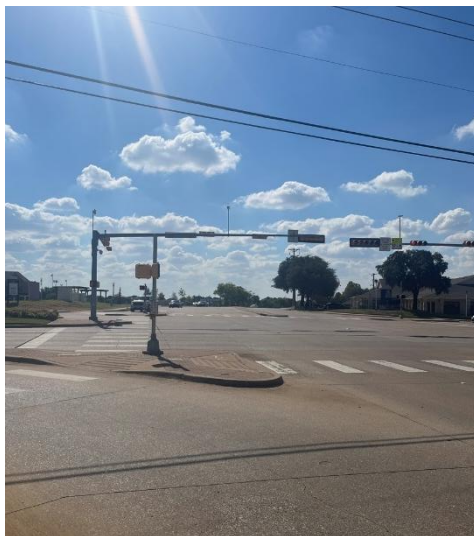
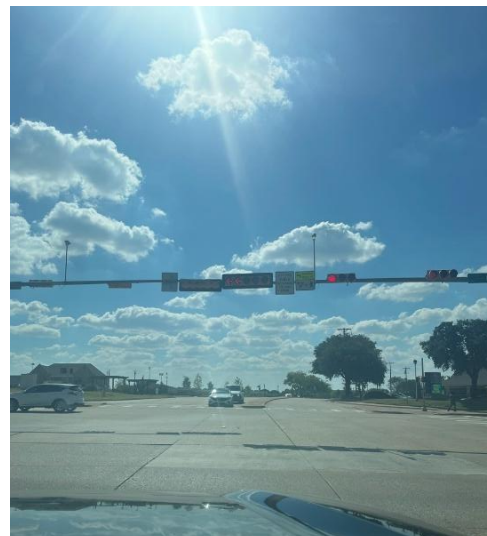
Figure 10. Sight Distance Issues

It has been observed that there are vertical and horizontal sight distance issues for road users in the southbound lane. This causes potential conflicts with the northbound left turn that must yield to southbound oncoming traffic. To remedy this, it is recommended to examine the signal timing and potentially add a protected left-turn phase to the signal timing. (Figure 10)

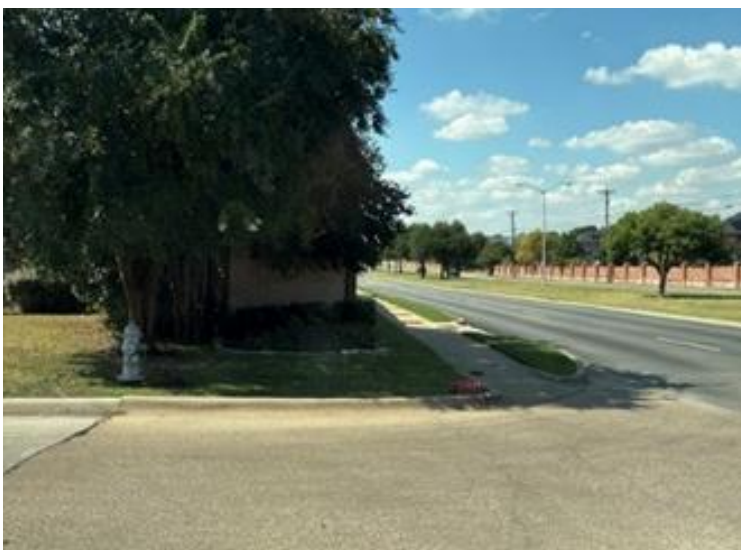
*Figure 12. Clear Trees*

To improve sight distance, it is recommended to clear the tree that obstructs the view. The tree is currently blocking drivers' lines of sight, making it difficult to see oncoming traffic or pedestrians, particularly when approaching the intersection and vehicles making a left turn. Clearing the tree will enhance visibility, reduce the risk of collisions, and allow for safer and more efficient movement through the area. (Figure 12)

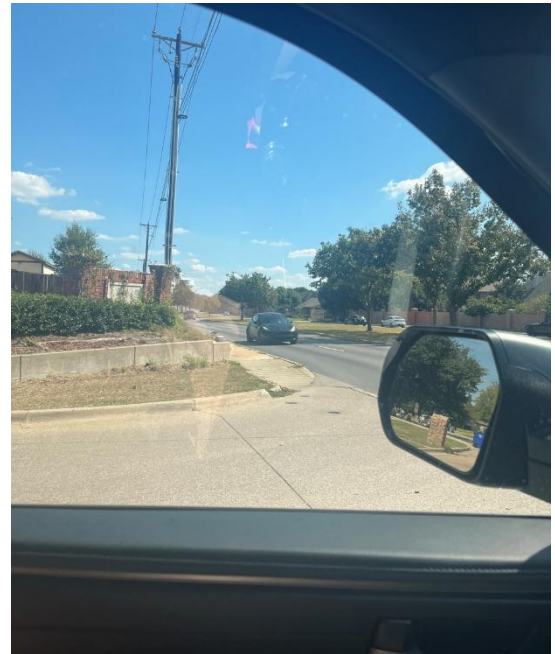
*Figure 11. Conduct Traffic Warrant Study*

Due to the observed speeding, high crash count, and long distance between nearby signals, it is recommended to signalize this intersection. (Figure 11)

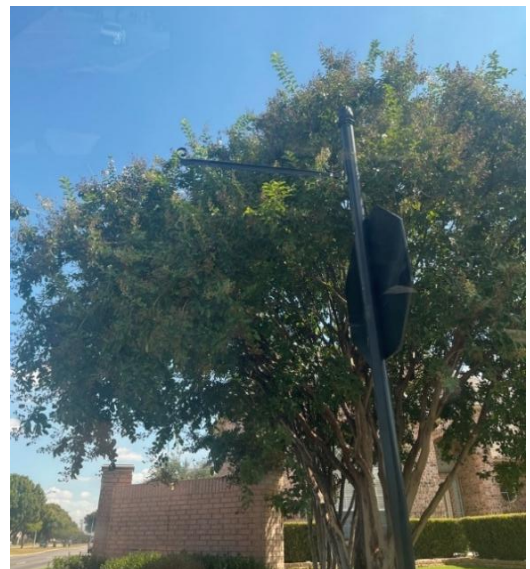
*Figure 13. Replace Street Name Sign*

The street name sign is missing. It is recommended to replace the sign name to be more to road users for navigation. (Figure 13)

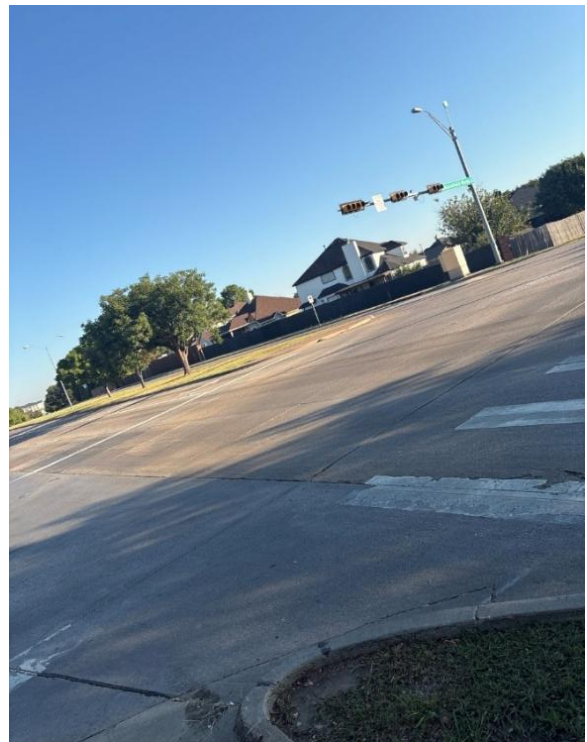
Figure 15. Relocate Crosswalk and Remove Cabinet

It is recommended to relocate the crosswalk to the north leg. This relocation will also require the relocation of the cabinet to remove the existing barrier for pedestrians on the sidewalk. This will enhance ADA compliance for use of the sidewalk. (Figure 15)

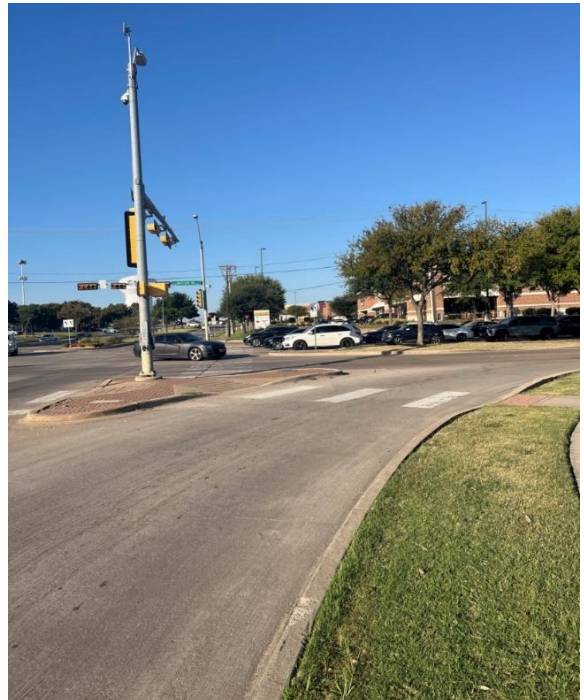
*Figure 17. Yield to Pedestrian Markings Needed*

There are 4 slip lanes at this intersection. To enhance safety for pedestrians, it is recommended to add necessary signage and pavement markings to yield to pedestrians (Figure 17).

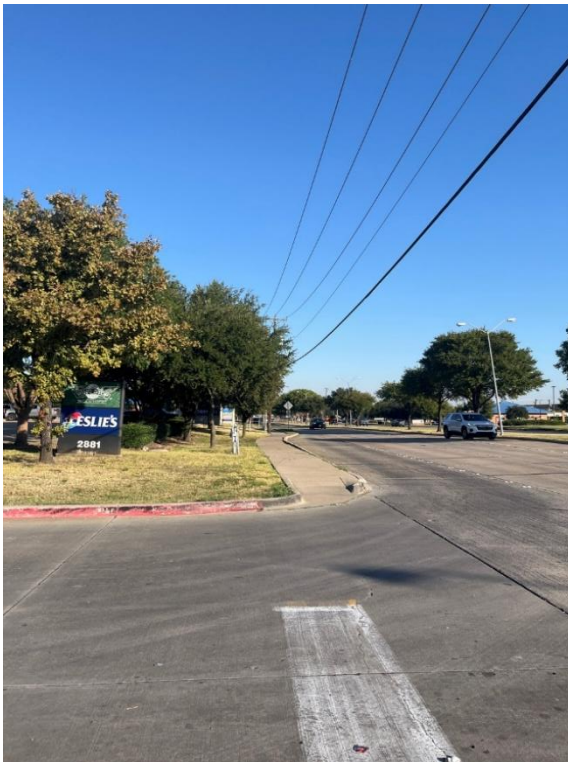
*Figure 18. Clearance Needed*

At this intersection, a tree and a utility pole are blocking the sight distance for a right turn (*Figure 18*). Clearing these items is recommended to improve sight distance.

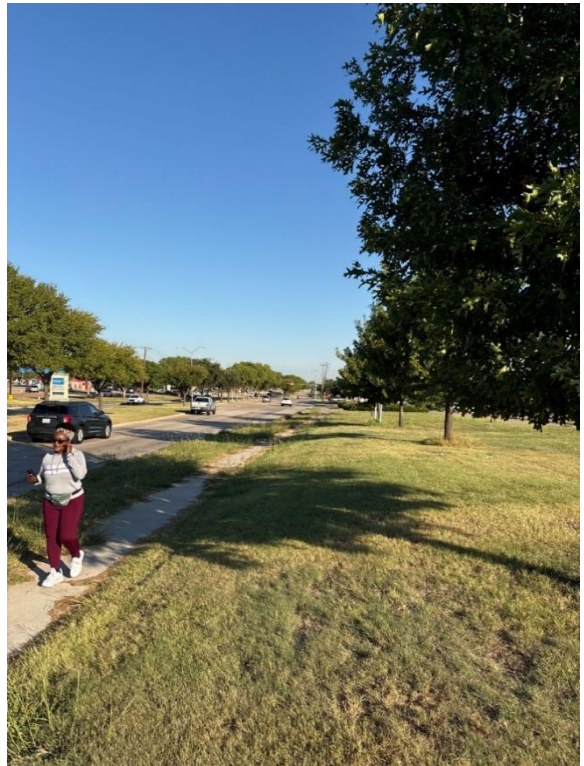
*Figure 19. Clear Sidewalk*

There is overgrown vegetation making it difficult for pedestrians to use the sidewalk (*Figure 19*). It is recommended to clear the sidewalk of vegetation.

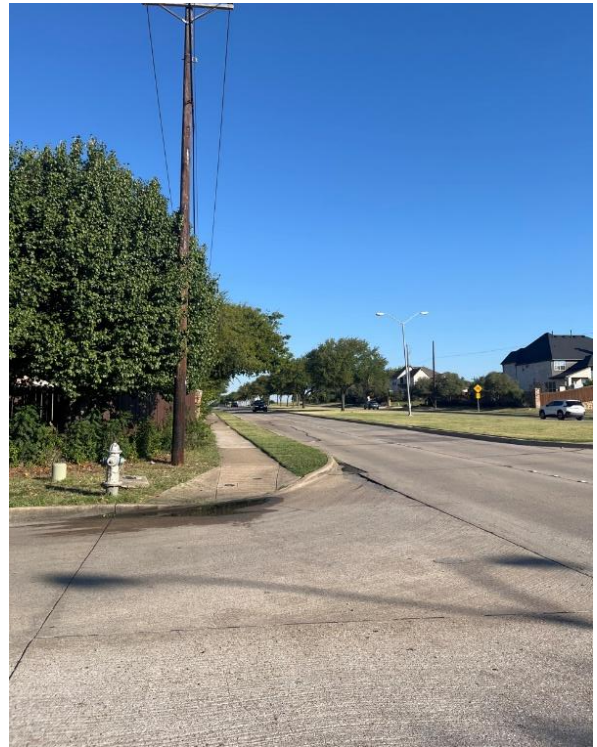
Figure 17. Install Hooded Left Turn Lane

Currently, the sight distance is poor. It is recommended to install a hooded left-turn lane for the northbound and southbound lanes. (Figure 17)

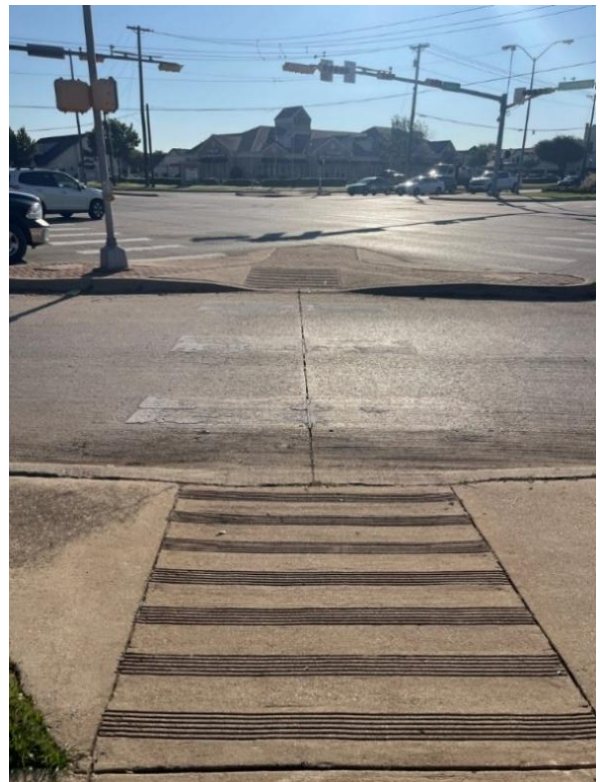
Figure 18. Detectable Surfacing Needed

To enhance pedestrian safety, it is recommended to upgrade the ramps to have raised pavement markers to indicate that the pedestrian is nearing the intersection. This upgrade is also necessary to ensure ADA compliance. (Figure 18)

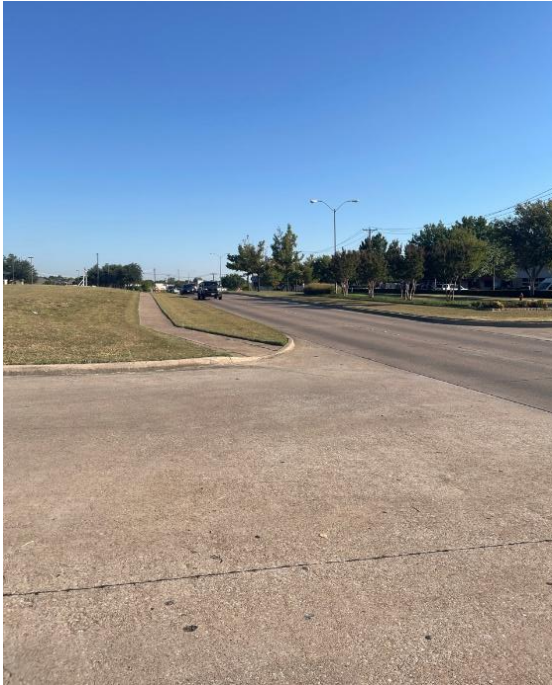
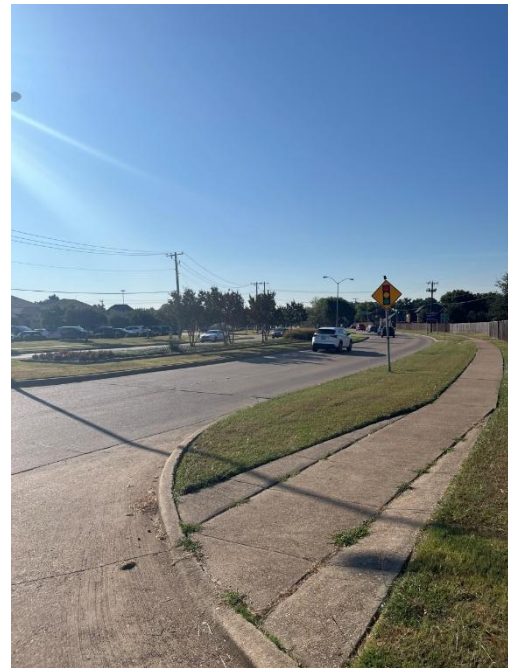
*Figure 19. Poor Sight Distance Observed (Looking East – left; Looking West – right)*

Poor sight distance was observed in both directions (Figure 19). To control access, the median should be closed and converted to a north- and southbound dual-hooded left turn lane.

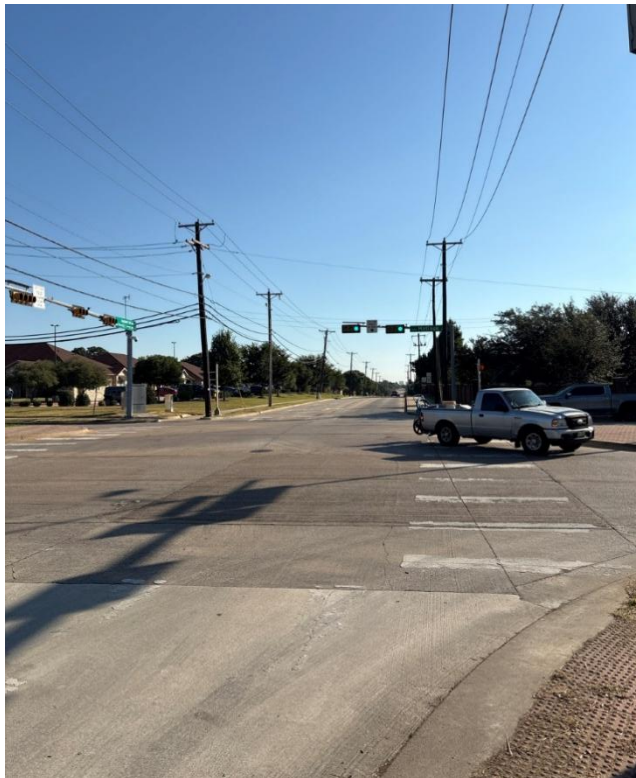
Figure 24. Add Flashing Yellow Arrow and Retroreflective Backplates

Currently, there is a left turn on a green signal. A flashing yellow arrow is recommended in place of the left turn on green ball. The flashing yellow arrow better communicates that left-turning drivers must yield to oncoming traffic and pedestrians. (Figure )

It is recommended that retroreflective backplates be added to the existing signals. This will enhance road users' visibility, reduce crash risk, and improve safety. (Figure )

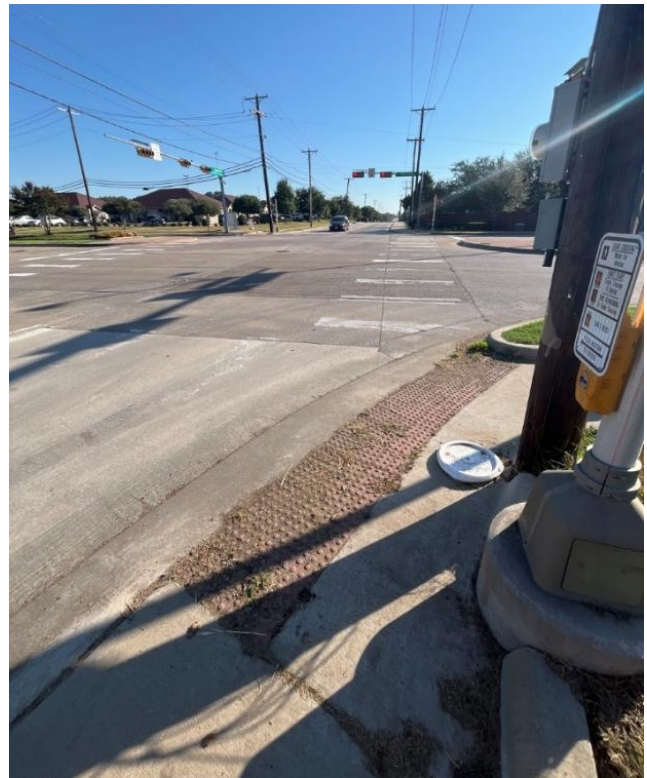
Figure 24. Upgrade to Directional Ramps

Directional curb ramps are recommended to improve accessibility and ensure compliance with ADA standards. These ramps will provide safe and convenient transitions between sidewalks and crosswalks for pedestrians, including those using wheelchairs, strollers, or other mobility aids.

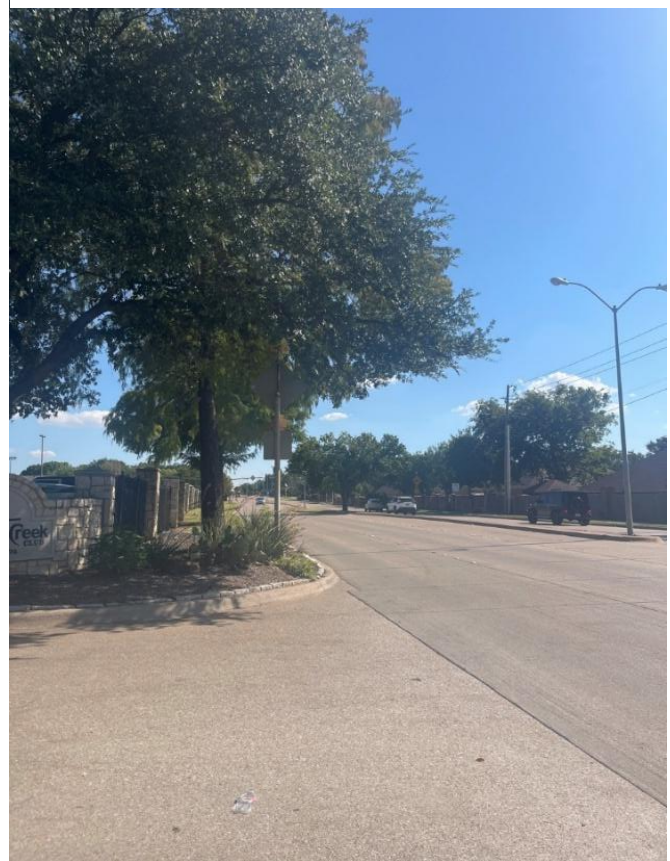
Figure 20. Recommended to Clear Trees to Improve Sight Distance

There are currently trees partially blocking the view. To improve sight distance, it is recommended to clear the existing trees so it is easier and safer for drivers to see westbound traffic. (Figure 20)

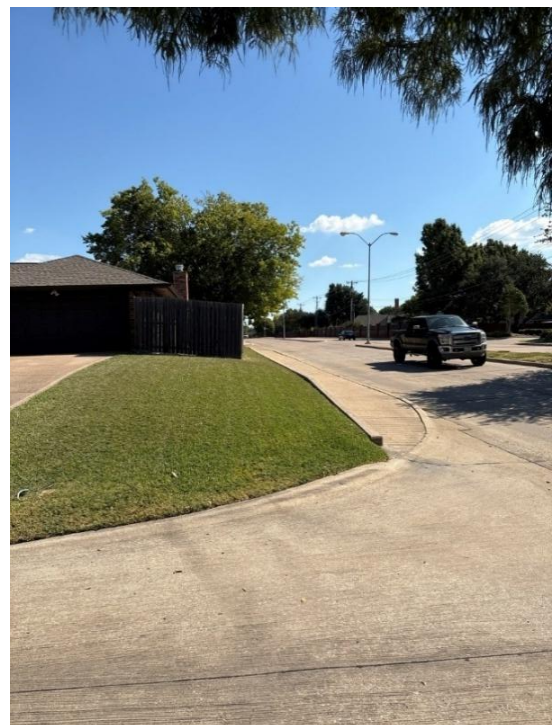
Figure 22. Relocate Fence

Currently there is poor sight distance at this intersection. It is recommended to relocate or clear the fence to allow for better sight distance (Figure 22)

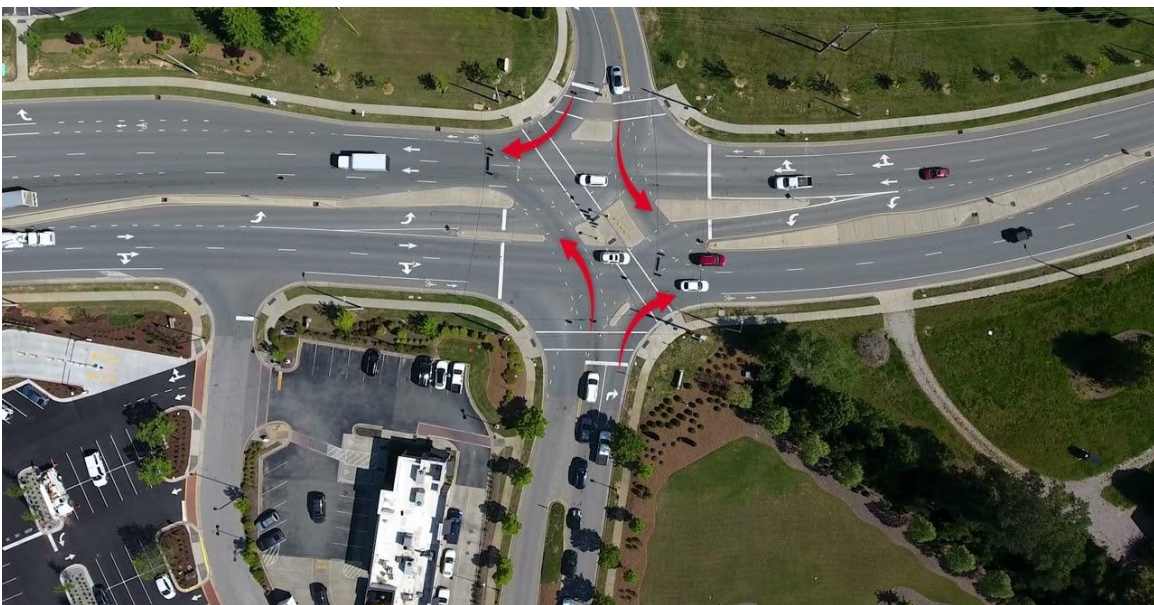
Figure 23. Thru-Cut Intersection

There is an existing traditional 4-way traffic signal. It is recommended to convert this signal into a signalized thru-cut intersection to prevent angled crashes. A thru-cut intersection is similar to a hooded left-turn median opening; however, it also allows left turns from the minor road.

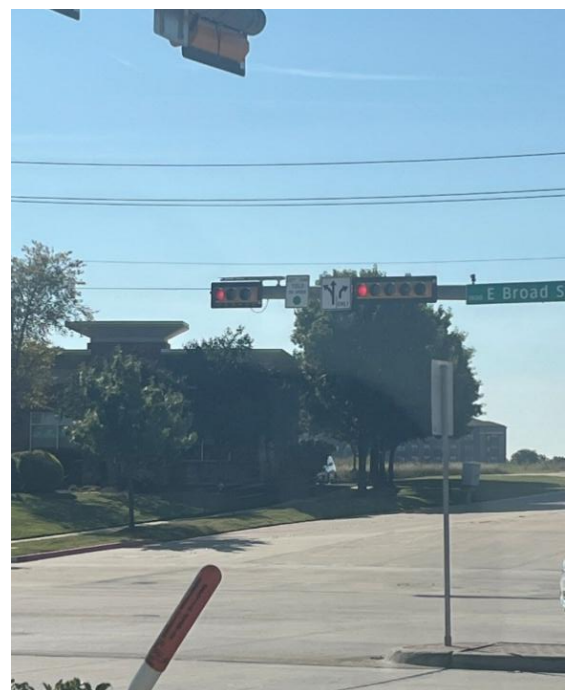
Figure 25. Upgrade Signage to Flashing Yellow Arrow

Currently, the left-turn lane has signage to yield on green. However, it is recommended to upgrade the signal to flashing yellow arrow to be more apparent to drivers to yield on the left turn. (Figure 25)

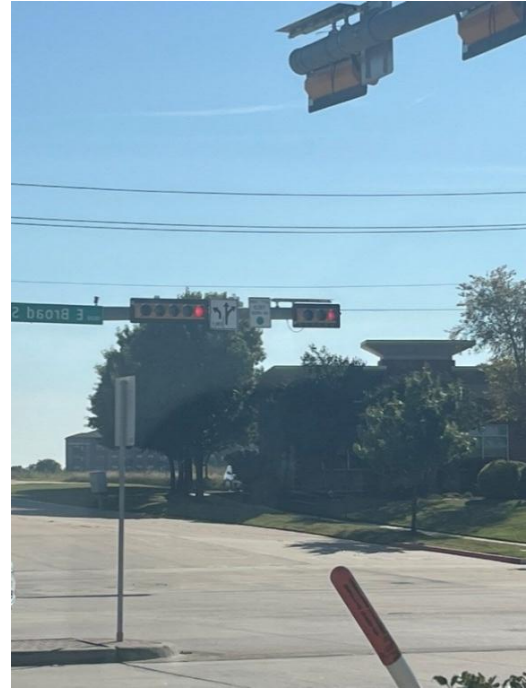
Figure 26. Replace Signage for Flashing Yellow Arrow

Currently, the left-turn lane has signage to yield on green. However, it is recommended to upgrade the signal to flashing yellow arrow to be more apparent to drivers to yield on the left turn. (Figure 26)

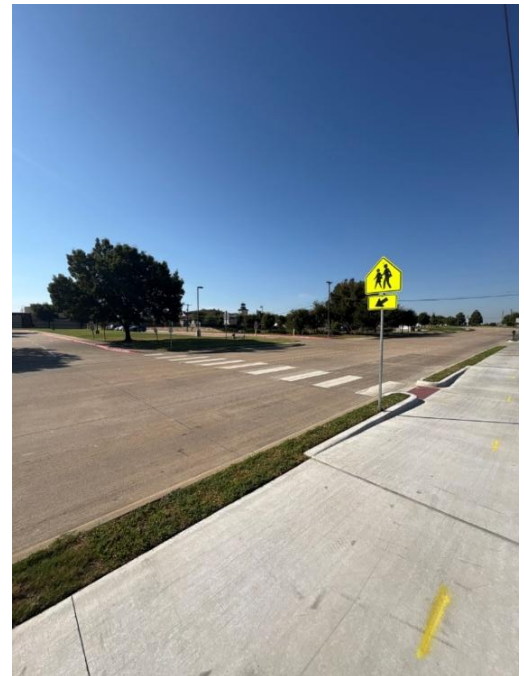
Figure 27. Upgrade Signage to Rectangular Rapid Flashing Beacon

To create a safer crossing for pedestrians, it is recommended to install a Rectangular Rapid Flashing Beacon, allowing pedestrians to have a designated crossing space. Flashing beacons also draw attention to pedestrian crossings, making them more visible to motorists, especially in low-light conditions or areas with high traffic volumes such as on Cannon Dr. with a volume of 5,200. (Figure 27)

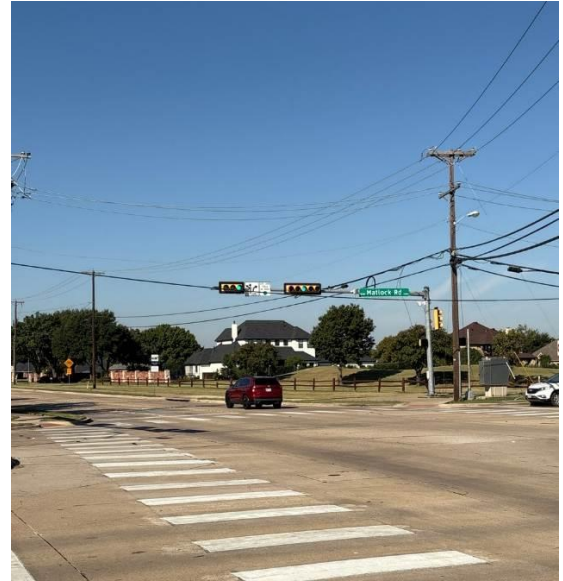
Figure 28. Flashing Yellow Arrow Needed

A flashing yellow arrow clearly communicates to drivers that they must yield to oncoming traffic and pedestrians before making a left turn, reducing the likelihood of collisions compared to traditional green ball signals. It is recommended to add a flashing yellow arrow at this intersection. (Figure 28)

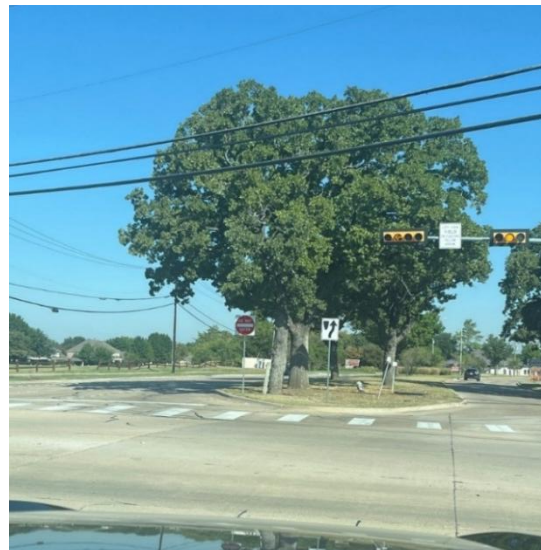
Figure 37. Install Protected Left Turn Lane

Sight distance at this intersection is poor. It is recommended to add a protected left turn to make a safer turn since there is limited visibility. By providing a designated lane for left-turning vehicles, conflicts with oncoming traffic, pedestrians, and cyclists are reduced, lowering the likelihood of accident. (Figure 37)

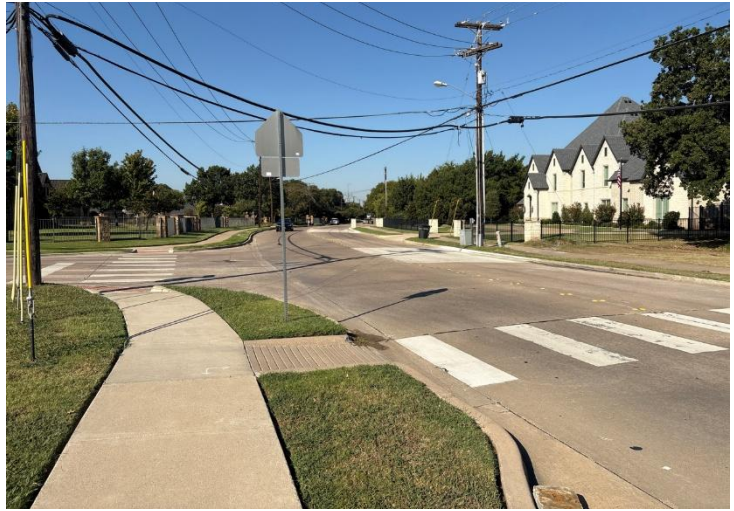
Figure 29. Install Mini-Roundabout

To slow traffic speed and improve traffic flow, it is recommended to install a mini-roundabout. This intersection being 3-legged, a mini roundabout will offer a more organized way for traffic to follow and encourage vehicles to slow down as they navigate. This is particularly useful with the intersection being in a residential area, ensuring a safer space for pedestrians as well. (Figure 29)

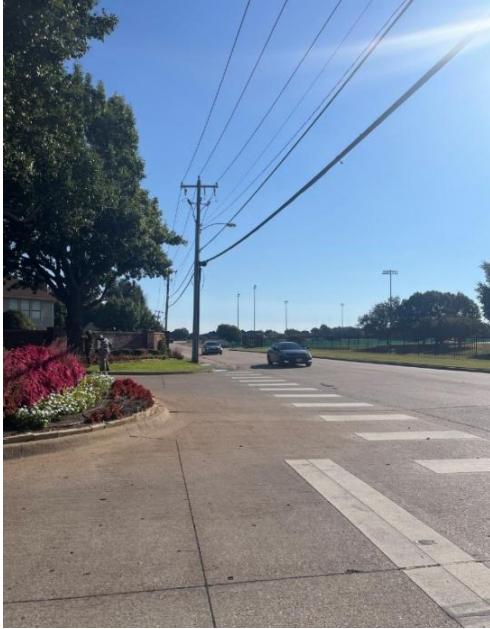
Figure 40. Relocate Fence

The fence currently blocks the sight distance looking east. It is recommended to relocate the fence to improve sight distance. (Figure )

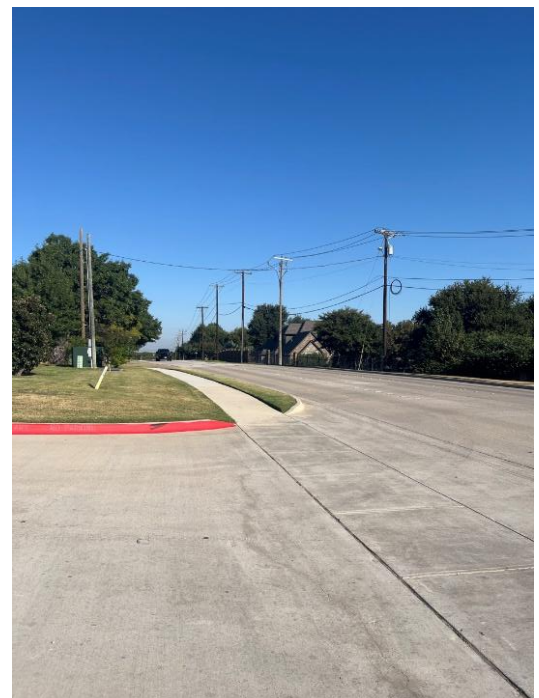
Figure 31. Install Dual-Hooded Left Turn

Currently, there is poor sight distance looking North (Figure 31). To enhance safety for left turns, it is recommended to install a dual-hooded left-turning lane with flexi-post. A dual-hooded left-turning lane guides vehicles into the turning lanes. The addition of flexi-posts further enhances safety by providing a flexible yet durable barrier that helps to clearly delineate the lanes, preventing improper lane changes.
