# ECTOR COUNTY: US 385

SH 158 Interchange to 2,000 ft. North of Interchange

Existing Conditions

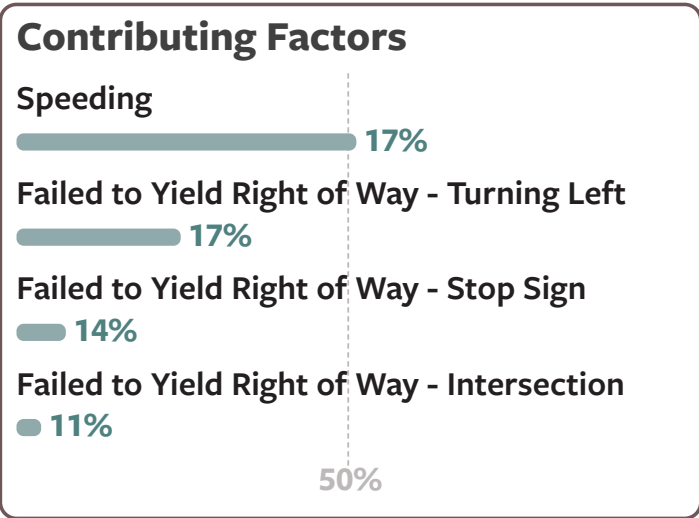
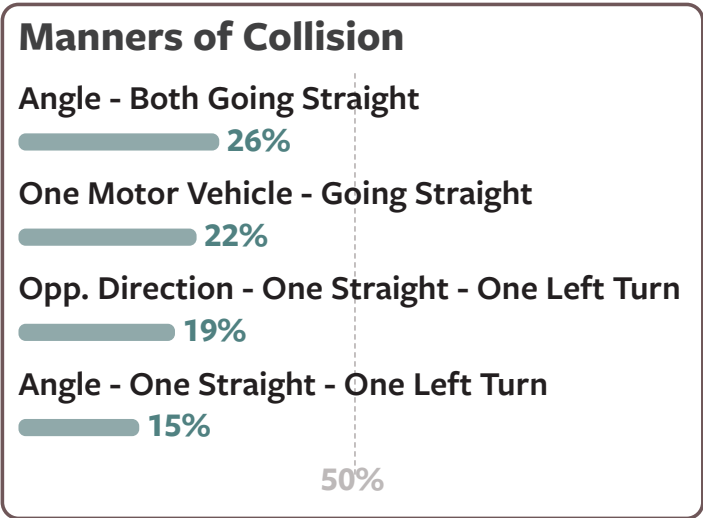
» High speeds by vehicles on US HWY 385

» Most crashes are occurring at the interchanges
