# UPTON COUNTY: SH 349

From 1,000 ft. South of CR 115 to 2,500 ft. North of CR 205

## Upton County: SH 349

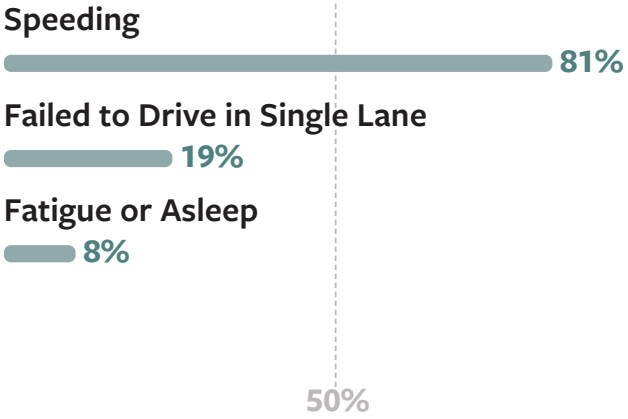
## Contributing Factors

- » Narrow paved shoulders
- » Horizontal curve in the middle of the corridor
- » Speeds too high for the curve

This section of SH 349 is a 3-lane undivided roadway with a speed limit of 75 MPH. While the surrounding areas are oil fields, the Upton Landfill is located near the center of the corridor. Due to the landfill and oil fields, this corridor experiences a large volume of heavy truck traffic.

Widen Paved Shoulders

Lighting

Appropriate Speed
