CHAPTER 4: COUNTERMEASURES

SYSTEMIC COUNTERMEASURE TOOLBOX

TARGETED RECOMMENDATIONS

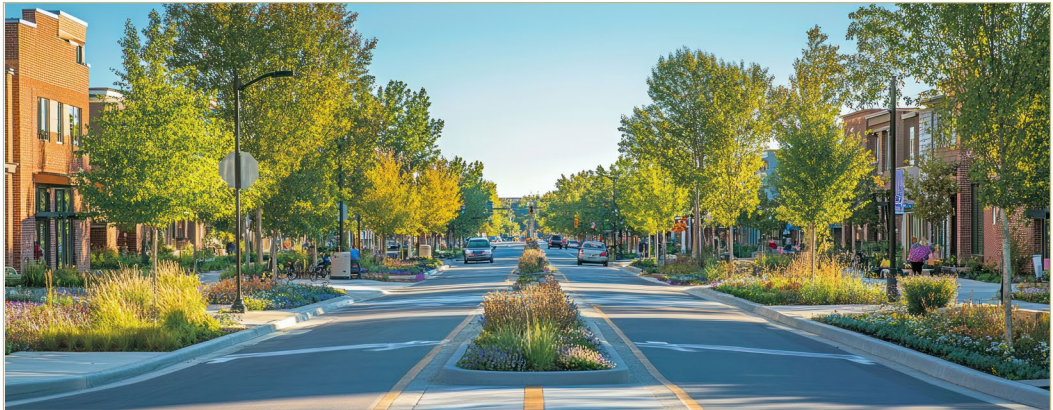
FIGURE 10. RAISED MEDIAN

A raised median is a physical barrier or divider that separates opposing lanes of traffic on a roadway. It is most used in urban and suburban areas to enhance safety and traffic flow by preventing vehicles from crossing over into opposing lanes or making certain left-turn movements. Installing a raised median has a CMF of 0.29 for all crash types and severities. **Figure 10** provides an example of a raised median.

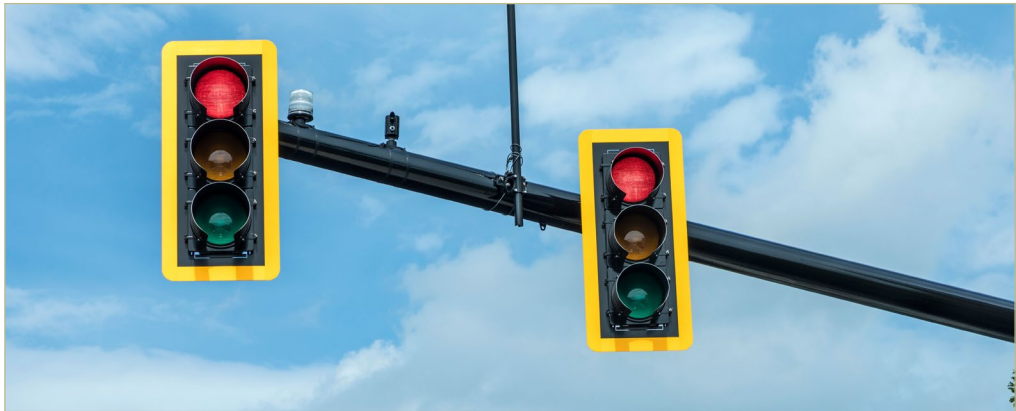
FIGURE 12. RETROREFLECTIVE BACKPLATE

A retroreflective backplate is a backplate made by framing a signal head with a 1-to-3-inch yellow retroreflective border. They improve the visibility of the illuminated face of the signal by introducing a controlled-contrast background. They are also more visible and conspicuous in both daytime and nighttime conditions. Installing retroreflective backplates has a CMF of 0.85 for all crash types and severities. **Figure 12** provides an example of a retroreflective backplate installed on a signal head.

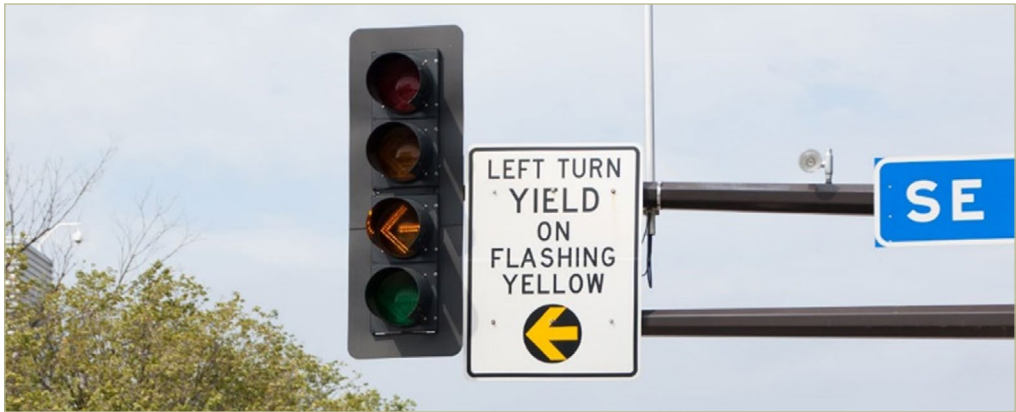
FIGURE 13. FLASHING YELLOW ARROW

A flashing yellow arrow (FYA) indicates that drivers are permitted to turn left but should yield to pedestrians and oncoming traffic during a permissive circular green. This countermeasure is a national standard adopted by the FHWA meant to increase intersection safety. The addition of an FYA is meant to decrease the number of left-turn crashes, especially those that involve a crash between vehicles turning left and those going straight. Installing an FYA has a CMF of 0.975. **Figure 13** shows an example of an FYA installed at an intersection.

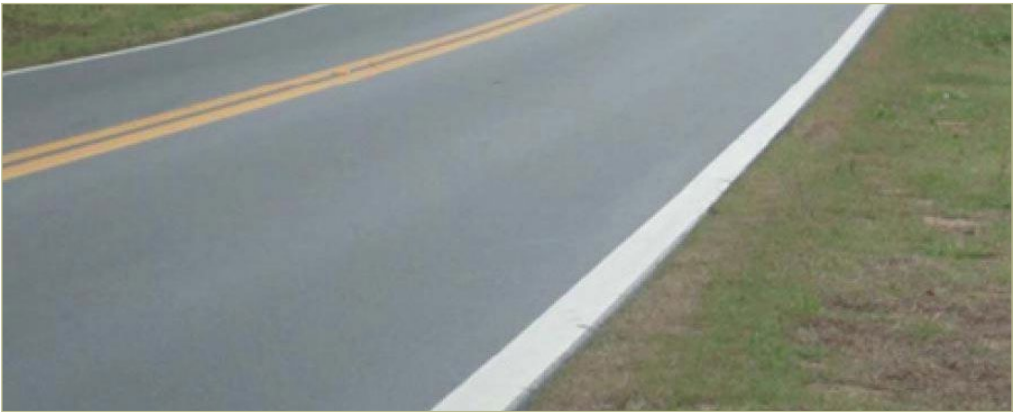
FIGURE 14. WIDE EDGE LINE

Edge lines are the pavement markings at the edge of travel lanes and are designed to help drivers clearly identify the road alignment ahead. Edge lines are considered “wider” when the marking width is increased from the minimum normal line width of 4 inches to the maximum normal width of 6 inches. Wider edge lines enhance the visibility of travel lane boundaries compared to traditional edge lines. This has a CMF of 0.635 for all crash types and for K, A, B, or C crash severities. **Figure 14** provides an example of a wide edge line.

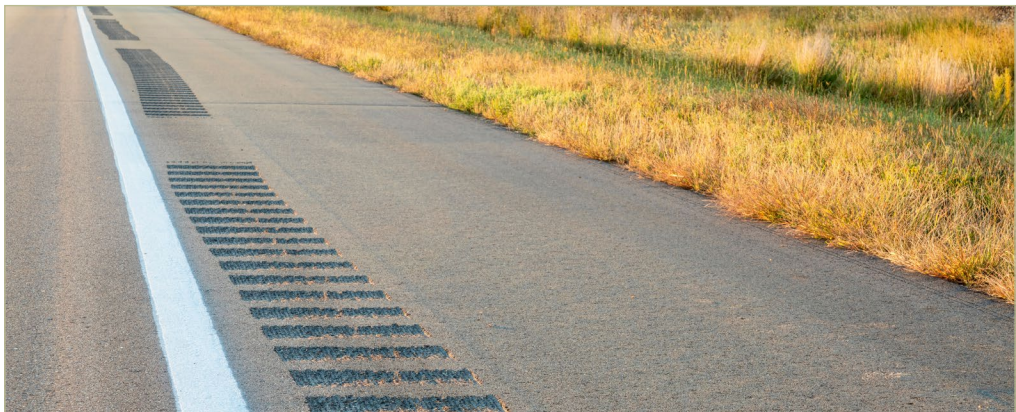
FIGURE 16. RUMBLE STRIPS

Rumble Strips are a method of improving traffic safety by alerting drivers in the case that they leave the traveled way. In the instance that a driver strays from the travel lane rumble strips will produce a noise and vibration that will alert drivers prompting them to correct the error. Longitudinal, center line, edge line, and shoulder rumble strips are effective low-cost safety countermeasures. Longitudinal rumble strips can result in a 44-64% reduction in head-on fatal and injury crashes on two-lane rural roads. Installing rumble strips have a CMF of 0.36. **Figure 16** shows an example of longitudinal rumble strips.

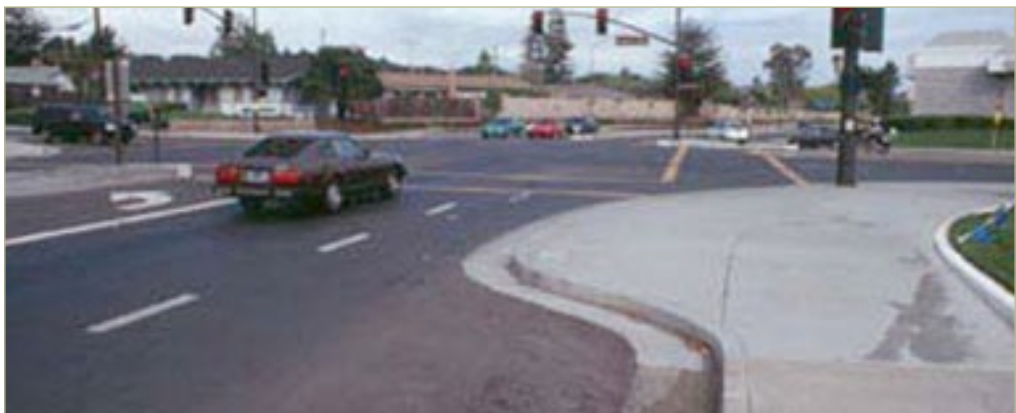
FIGURE 17. CURB EXTENSIONS

Curb Extensions visually and physically narrow the roadway, creating a safer and shorter crossing for pedestrians while increasing the available space for pedestrians or other amenities. Curb Extensions help with speed reductions and increased safety. There is currently not CMF for Curb Extensions. **Figure 17** provides an example of curb extensions.

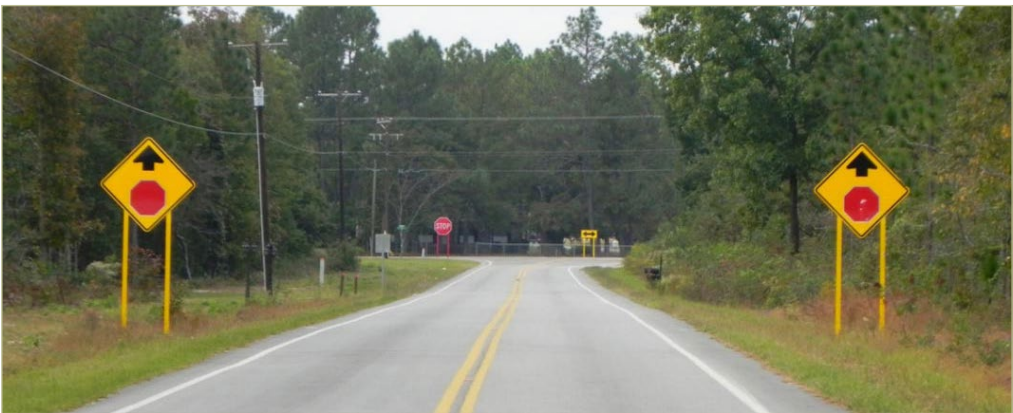
FIGURE 18. EXAMPLE OF COUNTERMEASURES AT A STOP CONTROLLED INTERSECTION

Deploying a variety of low-cost countermeasures at a number of stop-controlled intersection within a jurisdiction can increase overall intersection safety in that location. Countermeasure that could applied to stop-controlled intersections are properly placed stop bars, doubled-up oversized stop signs, doubled up oversized advance “stop ahead” signs, and removal of vegetation. These countermeasures increase driver awareness to the upcoming intersection and any potential conflicts. Implementing signing and marking improvements at stop-controlled intersections through a systemic approach has a CMF of 0.734. **Figure 18** provides an example of some low-cost countermeasures that could be utilized.

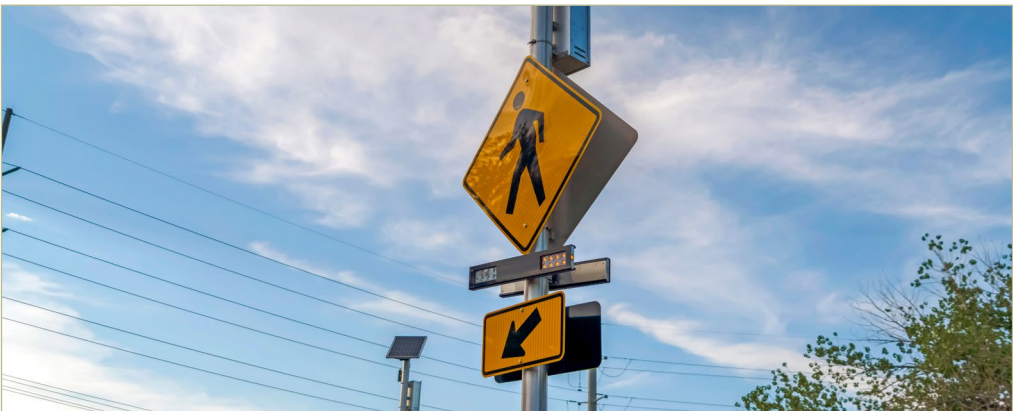
FIGURE 19. RRFB

A RRFB is a pedestrian activated safety device installed at crosswalks to enhance visibility and alert drivers to the presence of pedestrians. A RRFB consists of two, rectangular-shaped yellow indicators, each with a light emitting diode (LED)-array-based light source. When activated these the RRFB emits a rapid, alternating pattern of flashing lights to alert drivers to pedestrians crossing the street. RRFBs are a low maintenance improvement that should be deployed at targeted locations. According to FHWA, RRFBs can result in motorist yielding rates as high as 98 percent at marked crosswalks with varied speed limits, crossing distances, and number of travel lanes. Installation of an RRFB has a CMF of 0.31 for all crash types and severities. **Figure 19** provides an example of an RRFB.

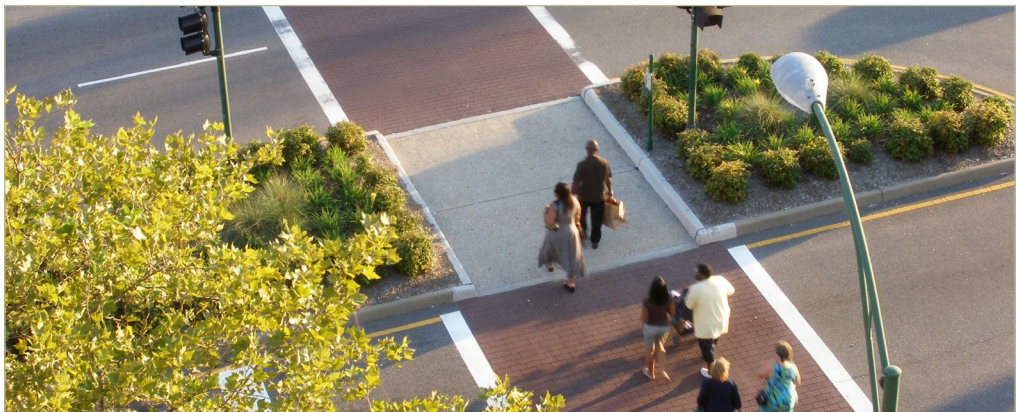
FIGURE 20. PEDESTRIAN REFUGE ISLAND

Pedestrian Refuge Islands is a dedicated pedestrian “island” in the middle of an intersection that provides a safe place for vulnerable road users to stop when crossing a large and busy intersection. Pedestrian Refuge Islands increase pedestrian safety by shortening pedestrian exposure when crossing an intersection. This safety countermeasure is most useful at intersections with high traffic volumes. Pedestrian Refuge Islands contribute to a 56% reduction in pedestrian crashes and have a CMF value of 0.44. **Figure 20** shows an example of a pedestrian refuge island.

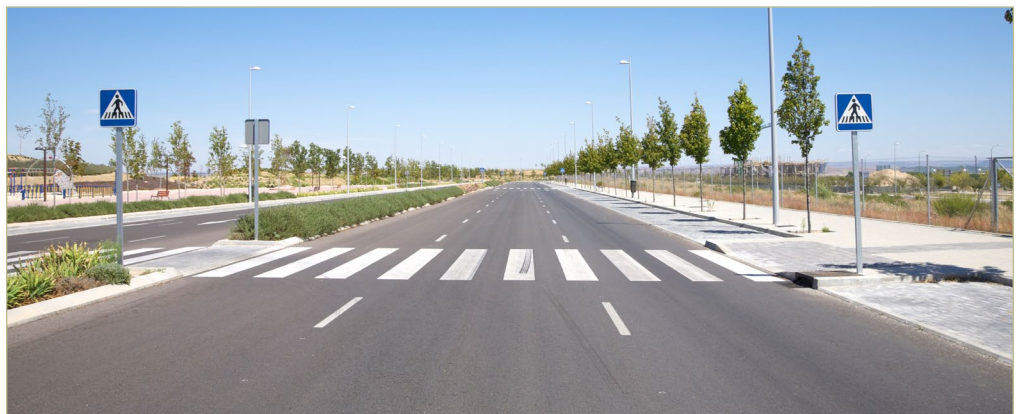
FIGURE 21. MIDBLOCK CROSSINGS

Designated pedestrian crossings away from an intersection. Inexpensive method to increase pedestrian safety through clear visual cues to pedestrians and drivers of a crossing, particularly in the case of increased distance between pedestrian crossing points. Increases vulnerable road user safety through alerting drivers to pedestrian crossings and encourage pedestrians to use dedicated crossing points. These treatments should be implemented at key locations where there are large expanses between pedestrian crossings at intersections. Installing Midblock Crossings has a CMF of 0.45. **Figure 21** provides an example of a midblock crossing.

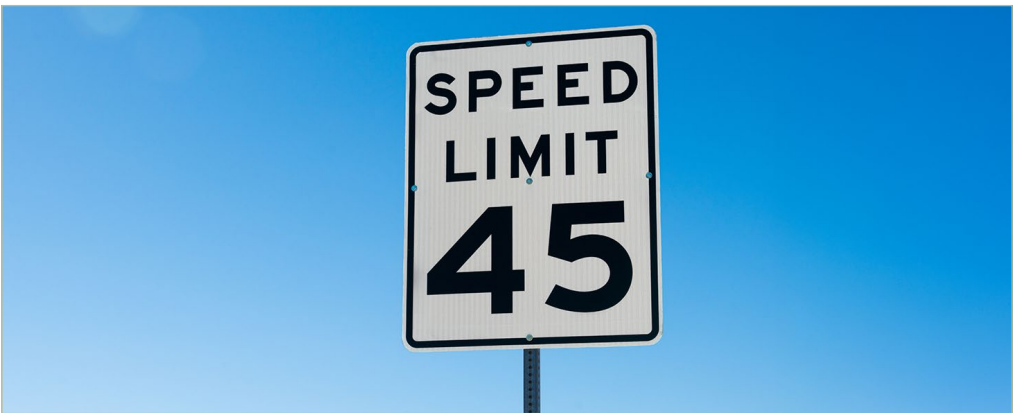
FIGURE 22. APPROPRIATE SPEED LIMITS

Utilization of appropriate speed limits increases roadway safety through implementing speed limits that take into account factors such as school/work zones, visibility, elevation changes, curves, congestion, and vulnerable road users. Through implementing appropriate speed limits into street design, it increases roadway safety for all users. Speeding increases fatality of all collisions, this low-cost method of speed control reduces danger of speed related collisions. A driver traveling at 30 miles per hour who hits a pedestrian has a 45 percent chance of killing or seriously injuring them. At 20 miles per hour, that percentage drops to 5 percent.

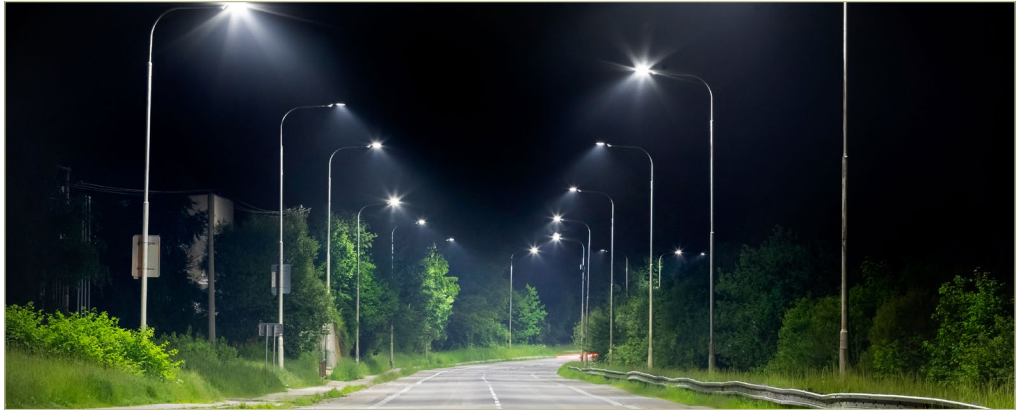
FIGURE 24. CORRIDOR LIGHTING

The number of fatal crashes occurring during daylight is roughly equal to those occurring in darkness. However, the nighttime fatality rate is three times higher than the daytime rate, despite only 25% of vehicle miles traveled (VMT) occurring at night. At higher speeds, vehicles may be unable to stop in time when a hazard or roadway change becomes visible within headlight range.

Enhancing roadway lighting significantly improves visibility and safety. Research-based recommendations for horizontal and vertical illuminance levels ensure lighting meets or exceeds minimum acceptable standards, benefiting all roadway users. Additionally, adequate lighting enhances personal security for non-vehicle users traveling along or across roadways. Depending on community needs, lighting improvements can take the form of intersection or corridor lighting. Increased lighting has been shown to reduce pedestrian nighttime crashes by up to 42%. Corridor lighting improvements have a CMF value of 0.73; an example of a well-lit roadway corridor is seen in **Figure 24**.

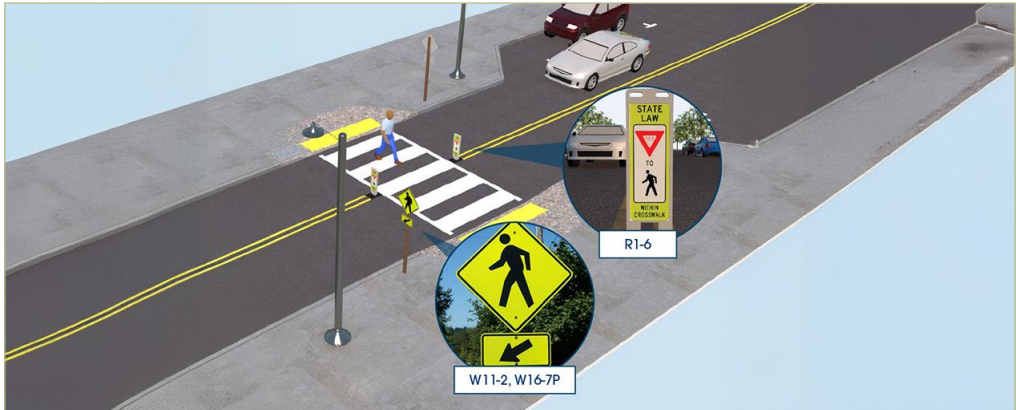
FIGURE 25. CROSSWALK VISIBILITY ENHANCEMENTS

Crosswalk Visibility Enhancements may include lighting, high-visibility crosswalks, and signing and pavement markings. These enhancements improve pedestrian safety by improving visibility and better alerting drivers of pedestrian presence. These low-cost improvements can be deployed on a large scale and encourage active transportation. Crosswalk Visibility Enhancements have a CMF of 0.732. Examples of visibility enhancements to a crosswalk is found in **Figure 25**.

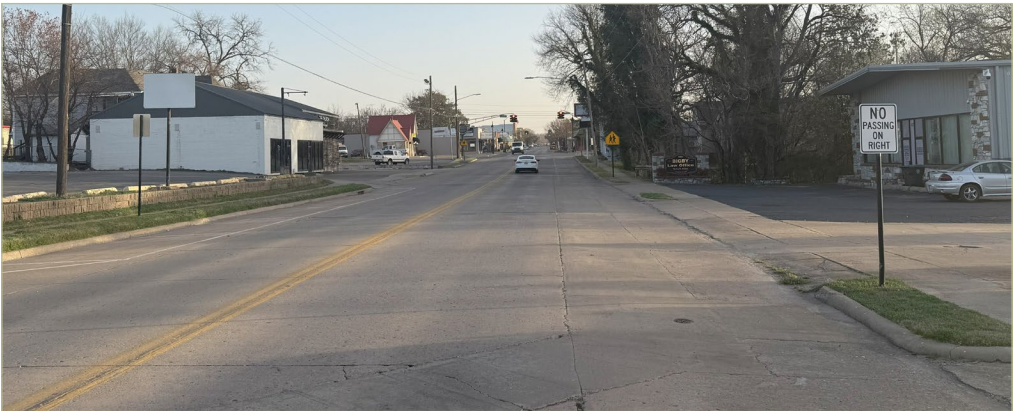
FIGURE 26. DRIVEWAY IN NEED OF CHANGE

Changing the width of existing driveways can have a significant impact on decreasing crashes near the driveway location. Through this countermeasure, driveways with large widths will not have to be fully closed but rather shortened to enhance intersection safety. Although this countermeasure reduced the degree of access a driveway has, it should be considered when limited sight distance does not allow adequate time to judge traffic, there is proximity to busy intersections, or there is a need to reduce conflicting turning movements. Reducing driveway widths in Tahlequah could have a CMF of 0.25 for all crash severities.

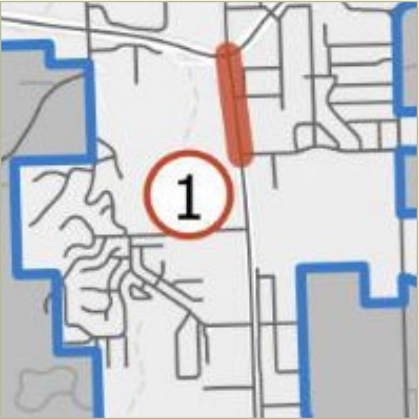
1 CORRIDOR 1: S MUSKOGEE AVENUE, FROM E. BALLENTINE ROAD TO BYPASS

The S Muskogee Avenue corridor (Corridor 1) is a section of Muskogee Ave, also known as US-62, from E Ballentine Road to the US-62/SH-82 Bypass that is 0.33 miles in length. Corridor 1 is located south of Downtown Tahlequah and is surrounded by primarily commercial land uses. This section of Muskogee Avenue is primarily a 5-lane undivided roadway with a center two-way left-turn lane. The volume of this road is approximately 20,800 vehicles per day. The posted speed limit of this corridor is 45 MPH. This corridor has two signalized intersections, one at the Bypass and one at Rayne Street, which acts as an entrance point to Walmart and Reasor’s.

It is recommended to install countermeasures along Corridor 1 that would both increase driver awareness and address both intersection and access management concerns. These countermeasures include installing corridor-wide high-contrast lane markings, a raised center median, improved lighting, transverse rumble strips, and steep hill warning signage. Raised medians will draw drivers’ attention to the way, help decrease speeds and improve access management along the corridor. High contrast lane markings enhance the visibility of the travel lanes throughout the corridor. This, paired with improved corridor lighting, will allow drivers to easily see in low-light conditions and see where travel lanes begin and end. Installation of transverse rumble strips and ‘Steep Hill Ahead’ signage will alert drivers about the steep hill south of Rayne Street; increasing driver awareness of these conditions is important so drivers are cognizant of speed and potential sight issues.

To enhance the safety of vulnerable road users, it is recommended to install sidewalks and ensure these sidewalks are adequately lit. There is an ODOT Transportation Alternative Project proposed to install a multi-use trail on the west side of the corridor that will address some vulnerable road user concern; it is recommended to connect this proposed trail to the east side of the corridor, as well as constructing sidewalks to connect to priority destinations, such as Walmart, Chick fil A, and Reasor’s.

Improved access management along this corridor is important, especially due to high traffic volumes and congestion seen here. Reduction of the number of driveway openings and creation of shared driveways between Rayne Street and Ballentine Road is recommended. Also, a designated ‘Entrance Only’ and ‘Exit Only’ driveway for Chick fil A is recommended.

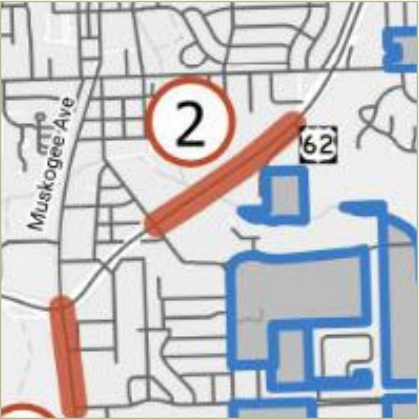
2 CORRIDOR 2: BYPASS FROM S PARK HILL ROAD TO 7TH STREET

The US-62/SH-82 Bypass corridor (Corridor 2) is a section of the Bypass from S Park Hill Road to 7th Street that is 0.55 miles in length. Corridor 2 is located southeast of Downtown Tahlequah and is surrounded by primarily industrial and agricultural land uses. This section of the Bypass is a 4-lane divided roadway. The volume of this road is approximately 17,500 vehicles per day. The speed limit varies on this corridor, with the southern half posted at 45 MPH and the norther half posted at 55 MPH. This corridor has one signalized intersection at S Park Hill Road.

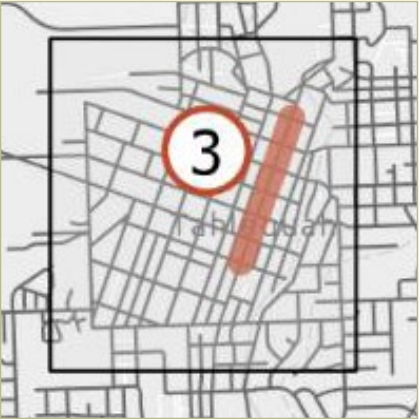
3 CORRIDOR 3: S MUSKOGEE AVE FROM W CHICKASAW STREET TO GOINGSNAKE STREET

The S Muskogee Avenue corridor (Corridor 3) is a section of Muskogee from W Chickasaw Street to Goingsnake Street that is 0.61 miles in length. Corridor 3 is in Downtown Tahlequah and is surrounded by primarily commercial and residential land uses. This section of Muskogee Avenue is primarily a 2-lane undivided roadway with parallel parking on each side of the road. The volume of this roadway is approximately 7,400 vehicles per day. The posted speed limit of this corridor is 25 MPH. This corridor has seven signalized intersections. This corridor also experiences heavy pedestrian traffic due to its high concentration of businesses and proximity to Northeastern State University.

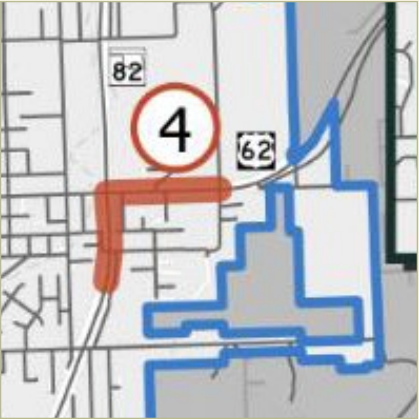
4 CORRIDOR 4: BYPASS/US-62 FROM E BOONE STREET TO E DOWNING STREET

The US-62/SH-82 Bypass and US-62 corridor (Corridor 4) is a section of these roadway from E Boone Street to E Downing Street that is 0.78 miles in length. Corridor 4 is located east of Downtown Tahlequah and is surrounded by primarily commercial and residential land uses. The volume of this road is approximately 16,000 vehicles per day. This section of the Bypass included in this corridor is a four-lane divided roadway, and the section of US-62 is a four-lane undivided roadway. The posted speed limit along the Bypass is 35 MPH and 45 MPH, while the posted speed limit along US-62 is 35 MPH. This corridor is a primary mover of traffic around Tahlequah and has important access to medical facilities, including the Northeastern Health System and Cherokee Nation W.W. Hastings Hospital.

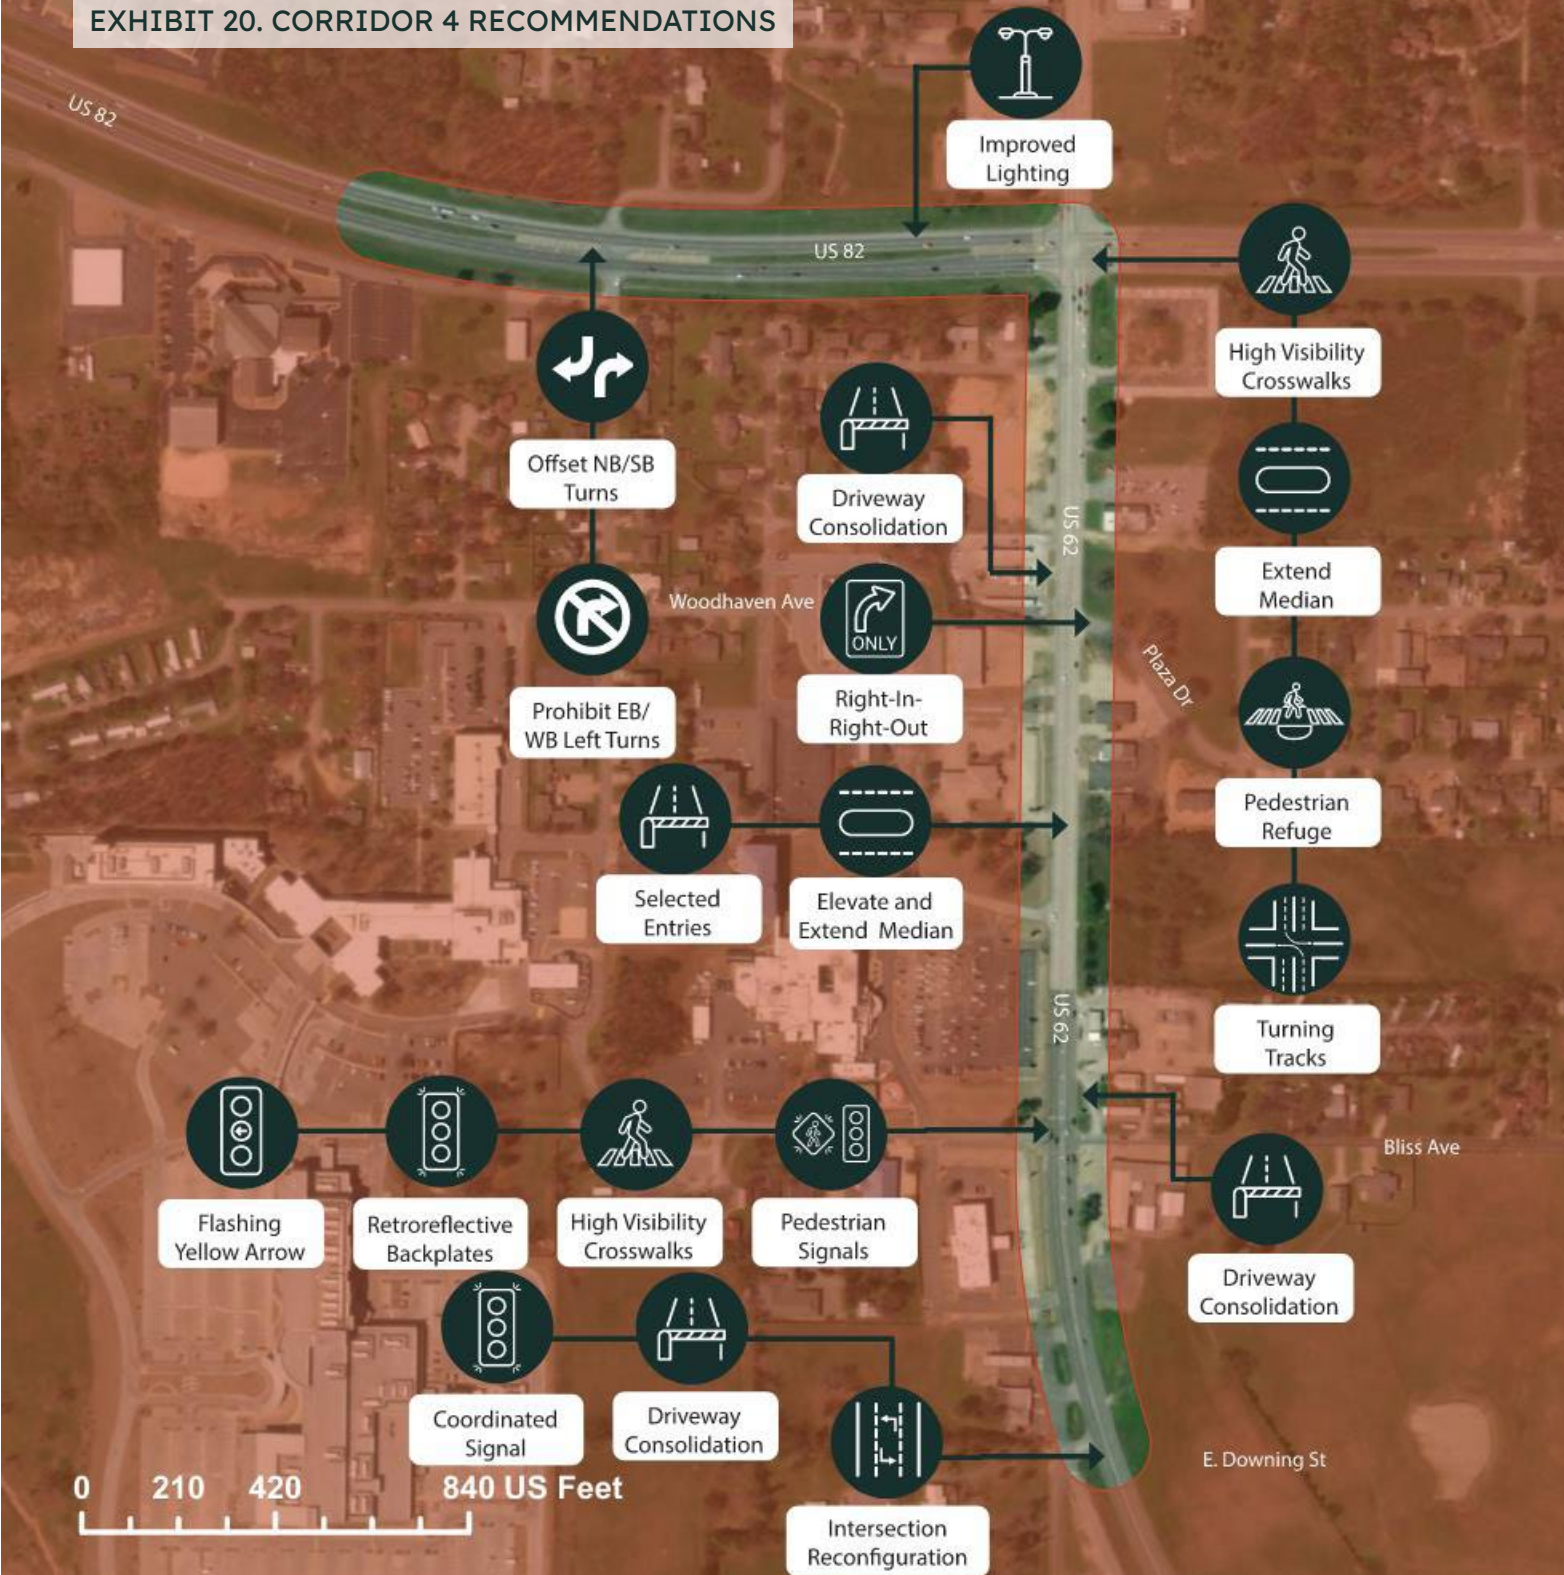
EXHIBIT 20. CORRIDOR 4 RECOMMENDATIONS

It is recommended to install countermeasures along Corridor 4 that would increase driver awareness and slow down speeds along the corridor. These improvements include installing high contrast lane markings, new shoulder rumble strips and wider edge lines. These improvements will increase the visibility of travel lanes throughout the corridor and alert drivers if they begin to depart the roadway.

For intersections on Corridor 4, it is recommended that dangerous driver maneuvers are eliminated, access management techniques are deployed, pedestrian access is improved, and signalized intersections are upgraded to include safety features.

- Install flashing yellow arrow left-turn signal heads.
- Install new retroreflective signal backplates.
- Install high visibility crosswalks.
- Add pedestrian crossing and pedestrian signals at missing approaches.
- Consolidate driveways at the business on the northwest corner of the intersection.

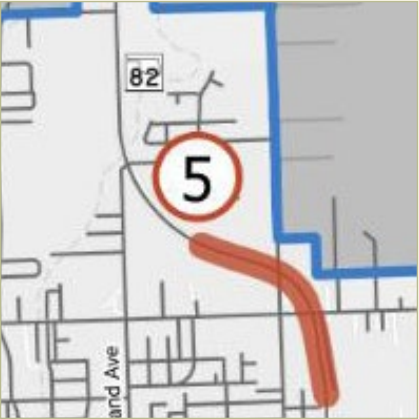
5 CORRIDOR 5: SH-82 NEAR E ALLEN ROAD

The SH-82 corridor (Corridor 5) is a section of this roadway located near E Allen Road that is 0.71 miles in length. Corridor 4 is located northeast of Downtown Tahlequah and is surrounded by primarily residential and agricultural land uses. The volume of this road is approximately 9,500 vehicles per day. This section of SH-82 is a divided 4-lane roadway. The posted speed limit is 55 MPH. The only signalized intersection along this corridor is at E Allen Road. This corridor serves as main entrance into the core of Tahlequah from the North. It is characterized by a significant curve from the just north of the E Allen Road intersection.

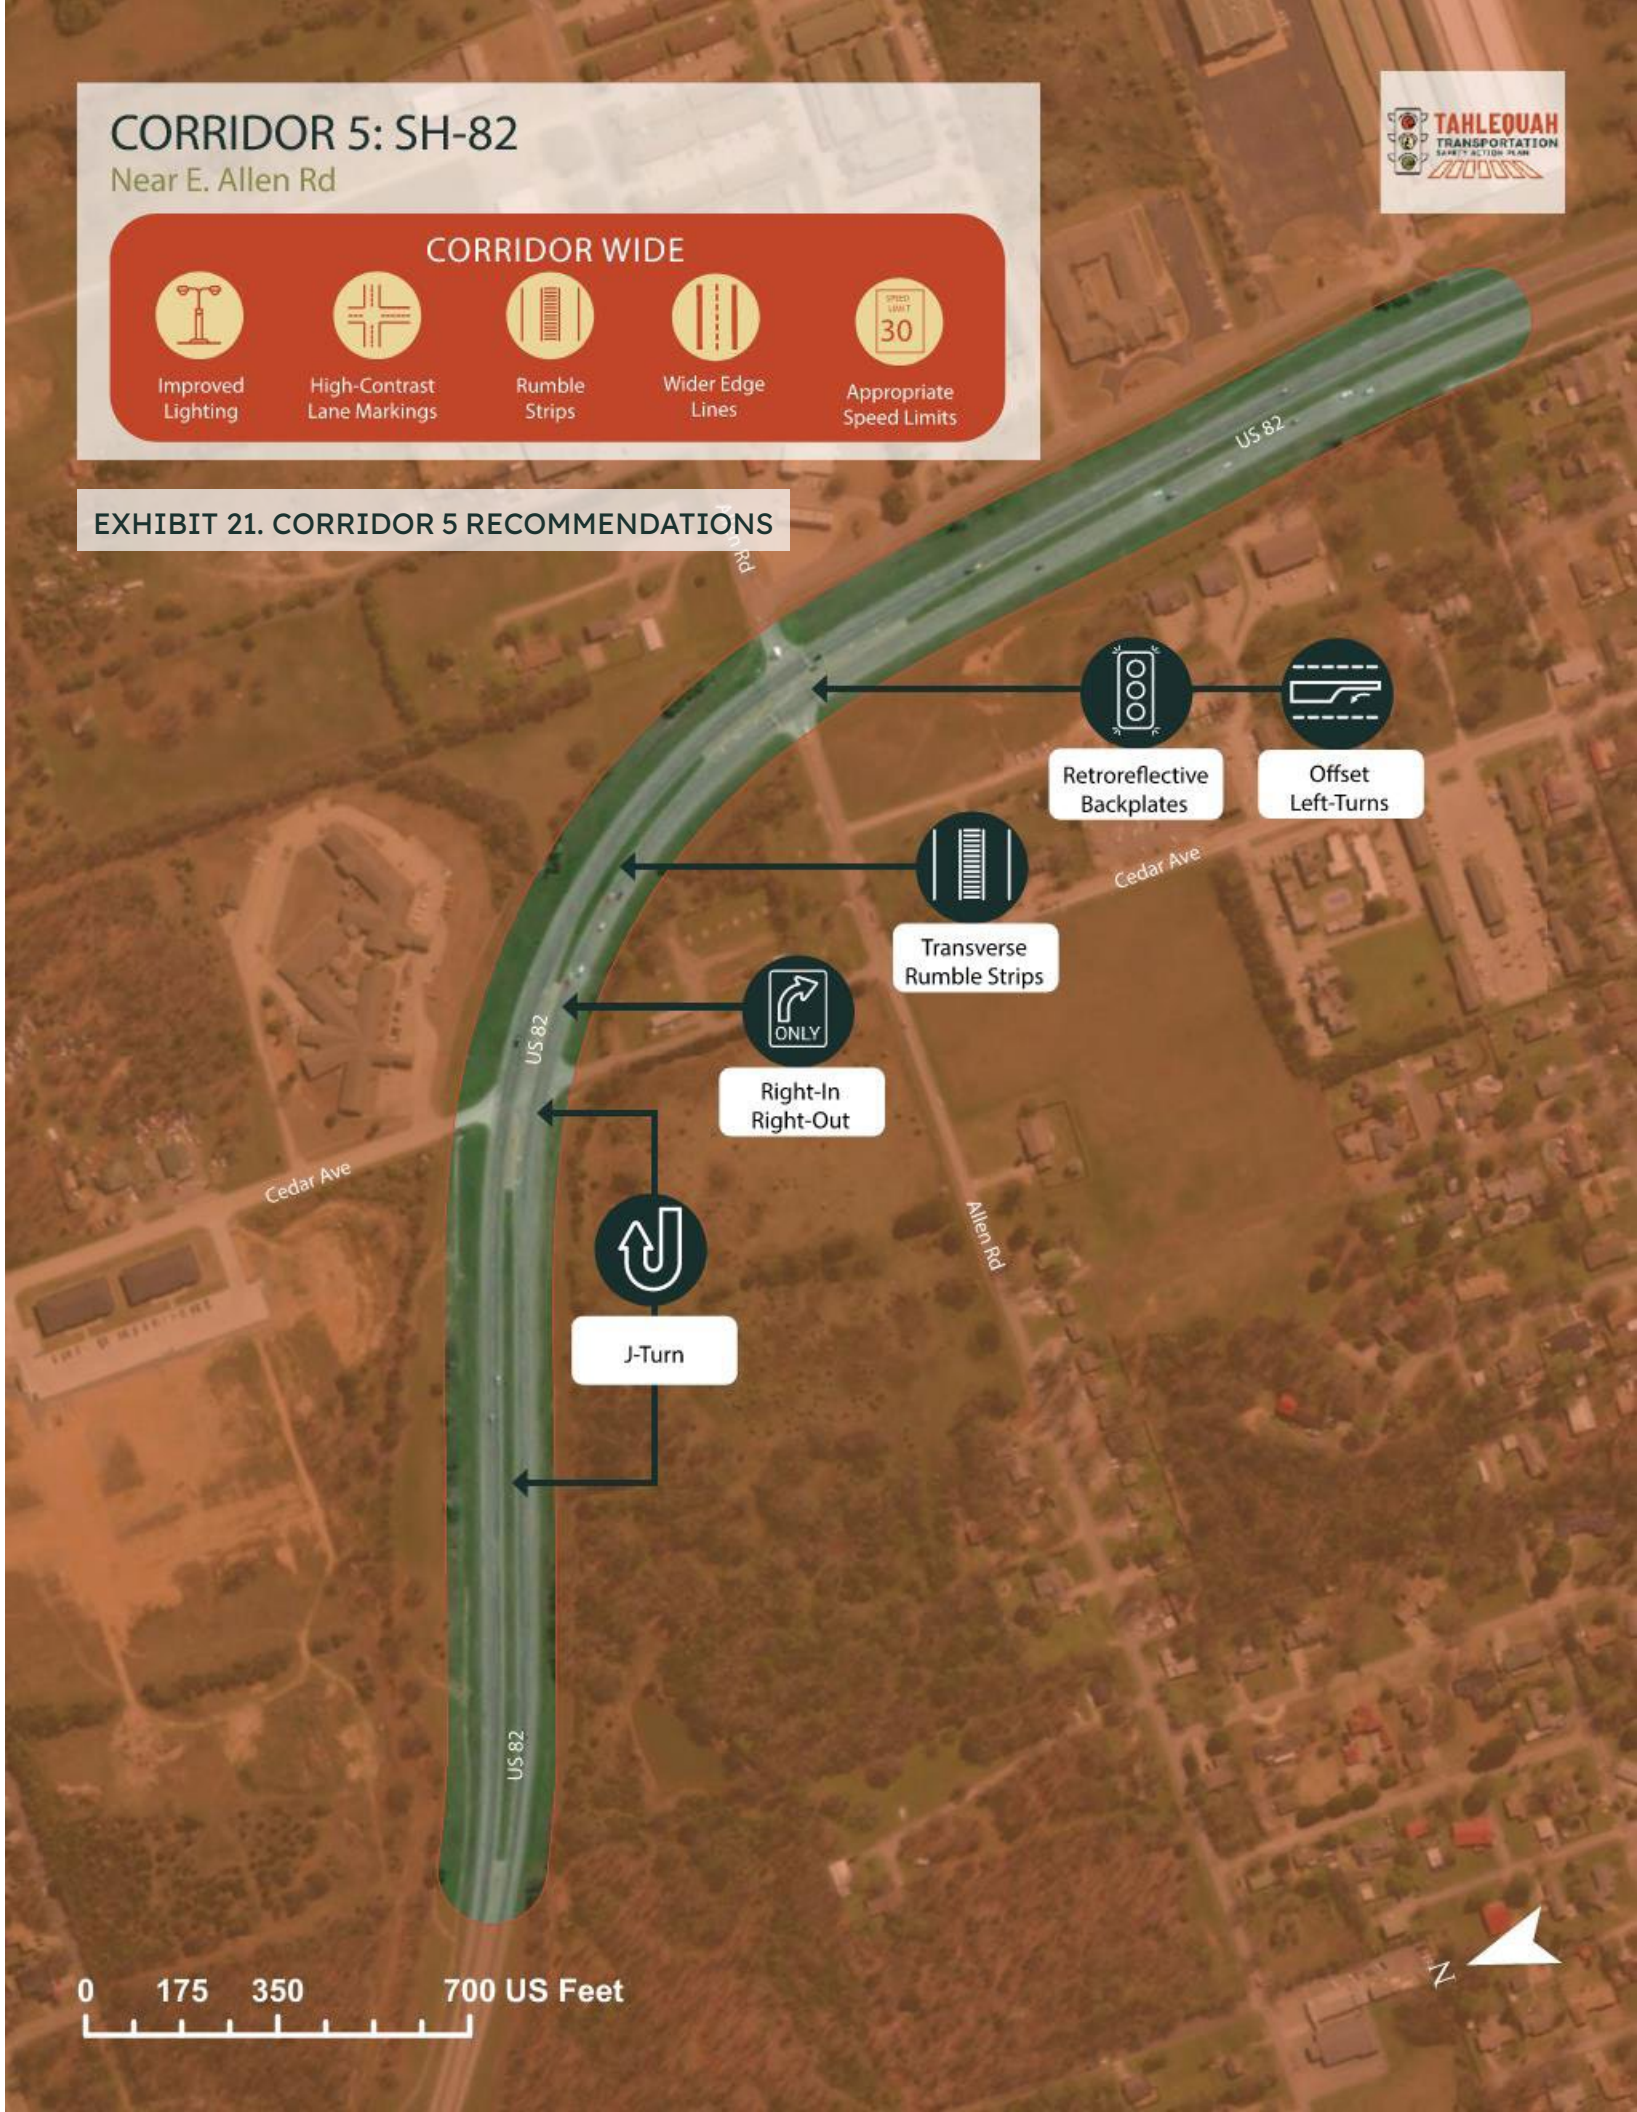
EXHIBIT 21. CORRIDOR 5 RECOMMENDATIONS

It is recommended to install countermeasures along Corridor 5 that would increase driver awareness. These countermeasures include installing high contrast lane markings, wider edge lane lanes, shoulder rumble strips, and improved roadway lighting. Wider edge lines and high contrast lane markings enhance the visibility of the travel lanes throughout the corridor. Installation of shoulder rumble strips along the edge line of the roadway will alert drivers if they begin the depart the roadway.

To further enhance the safety along this corridor, it is important to manage speeds. Management of speed limits along this corridor to safe and adequate speeds is recommended to reduce the severity of crashes; installation of speed feedback signs is a mitigation technique to reduce speeds.

For Corridor 5, the signalized intersection of SH-82 and Allen Road and the unsignalized intersection of SH-82 and Cedar Avenue have recommendations. It is especially pertinent to address the Cedar Avenue intersection do to the current intersection conditions contributing to the vast majority (72%) of the corridor crashes.
