# APPENDIX E

MANSFIELD ATSP FIELD OBSERVATIONS  
AND RECOMMENDATIONS

**To:** City of Mansfield  
**From:** Monica Powell, AICP, RSP<sub>1</sub>  
**Date:** November 5, 2025  
**Subject:** Mansfield ATSP – Field Observations and Recommendations

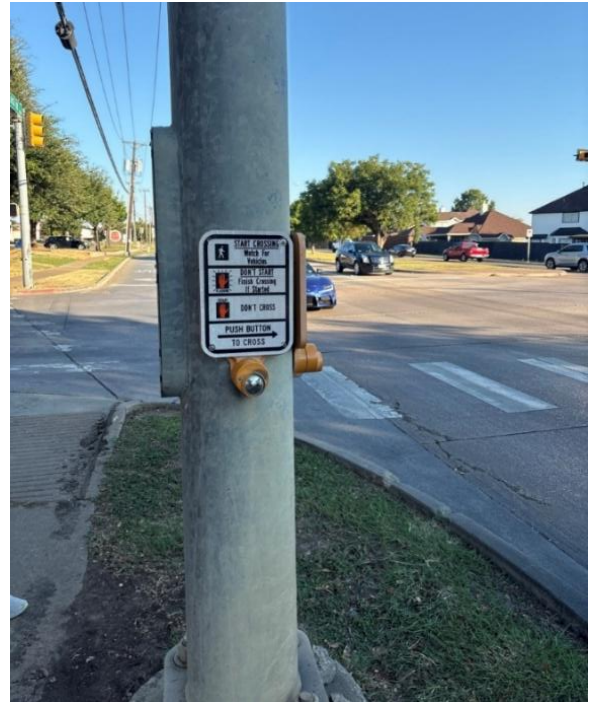
Figure 14. Update Needed to Pedestrian Push Buttons and Refreshing of Crosswalk

The existing pedestrian push buttons are not in ADA compliance as they do not provide audible cues for the user. (Figure 14)

Directional curb ramps are recommended to improve accessibility and ensure compliance with ADA standards. These ramps will provide safe and convenient transitions between sidewalks and crosswalks for pedestrians, including those using wheelchairs, strollers, or other mobility aids.

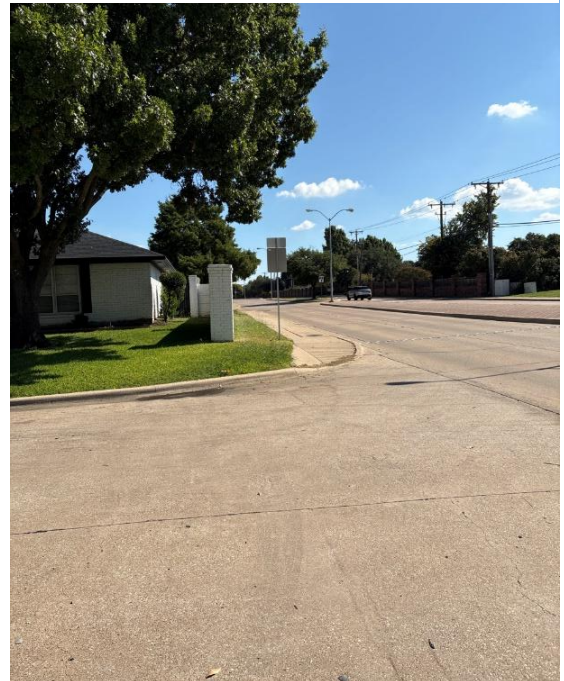
Figure 21. Clear Brick Wall

Sight distance is poor looking east. Consider moving the existing fence closer to the front corner to improve line of sight. (Figure 21)

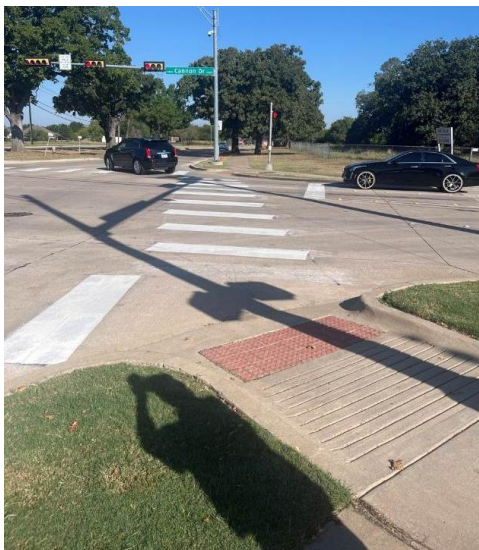
Sight distance at this intersection is poor. It is recommended to add a protected left turn to make a safer turn since there is limited visibility. By providing a designated lane for left-turning vehicles, conflicts with oncoming traffic, pedestrians, and cyclists are reduced, lowering the likelihood of accident. (Figure 37)

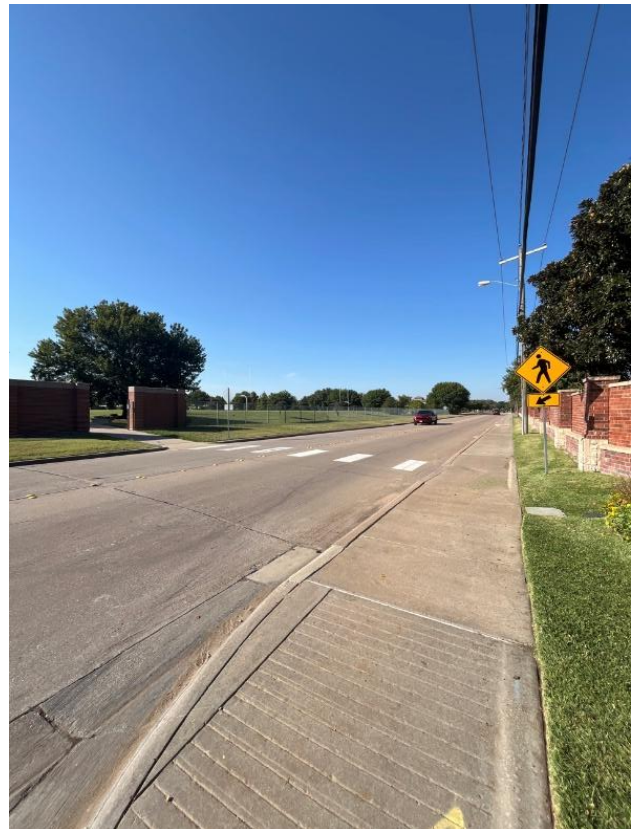
The fence currently blocks the sight distance looking east. It is recommended to relocate the fence to improve sight distance. (Figure )
